**MAJOR NEWMAN'S PONTVILLE:
FABRIC ANALYSIS AND ARCHAEOLOGICAL
INVESTIGATION OF AN EARLY COLONIAL HOME-
STEAD,
TEMPLESTOWE, VICTORIA
WITH
A COMPARATIVE STUDY OF SWEENEY'S
CULLA HILL, ELTHAM**

A report to Parks Victoria
June 2014

Roger Luebbers PhD
Consultant Archaeologist
August 1997
Revised June 2014

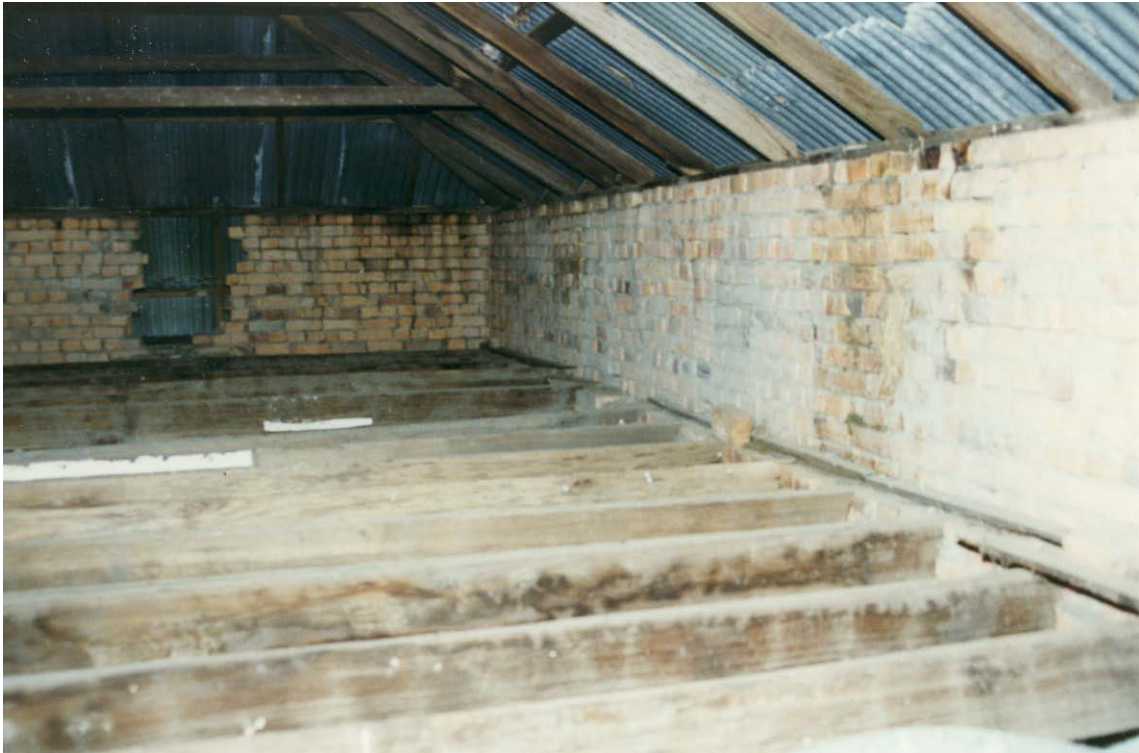
Photograph 10 Interior walls of loft. Slate, shingles, nails, and other fabric from former roof were found in crevices and ledges of the loft and in the sub-floor cavity below.

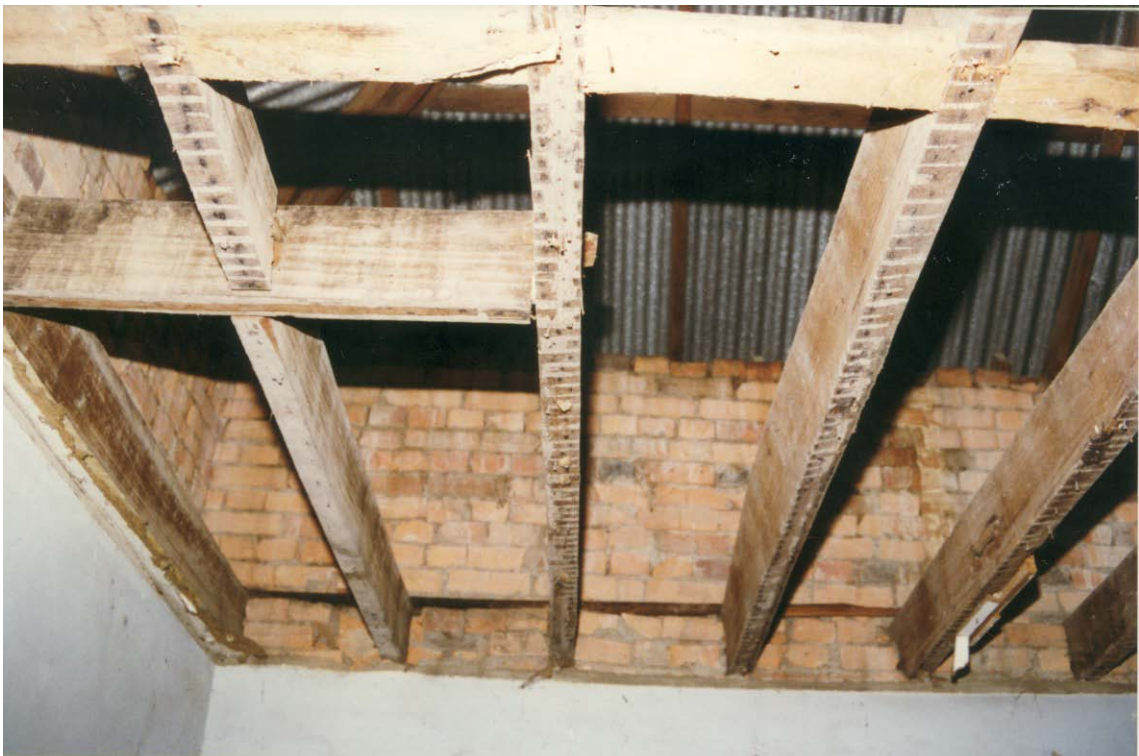
Photograph 11 Header beam and filler joist in loft opening, Pontville. Three shoulder and mortise joints are present in the beam and one of the tenons is fixed. Lath and plaster marks and nails are present on the underside of all joists, except the shorter joist that fills the former loft entrance.

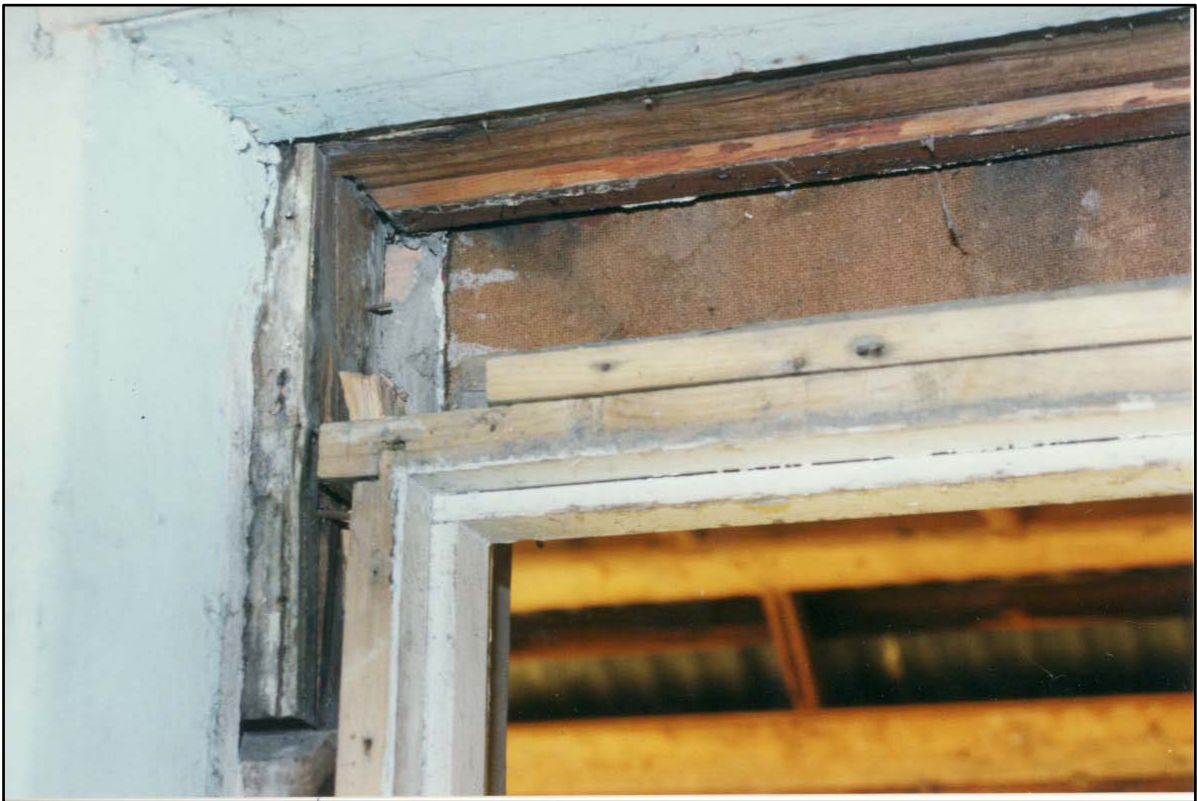
Photograph 17 *Detail of transom light frame, front door, with modern door frame representing alteration. A decorative architrave in a pale yellow paint is partially concealed by the lintel in the opening.*

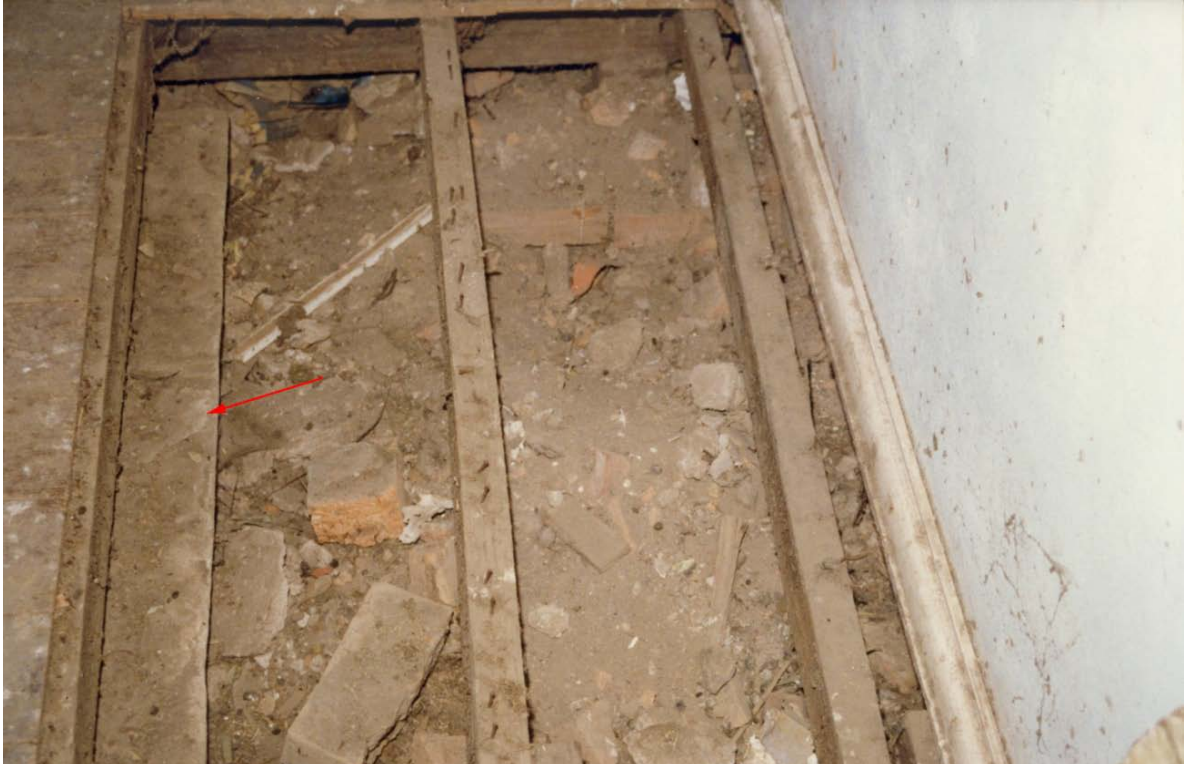
Photograph 18 *Fireplace opening in south room with edge of sandstone hearth stone, arrow, beneath ex-tant floor. The stone marks the original floor height. The demolition material beneath this floor contains significant mid-19th century fabric.*

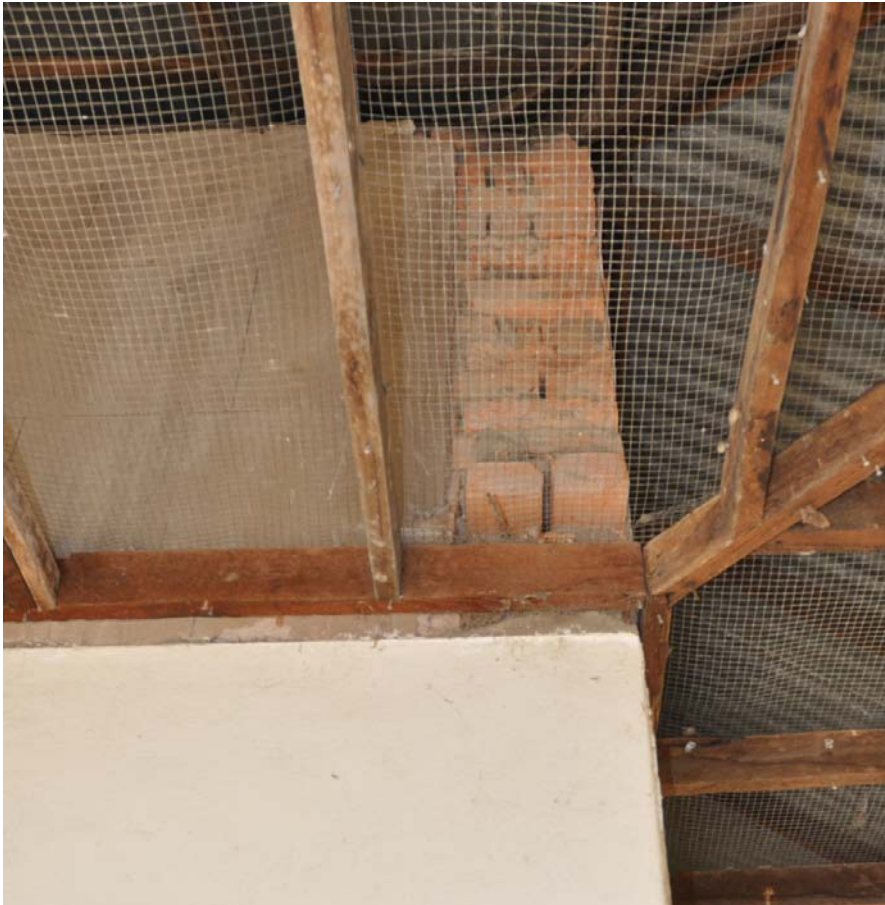
Photograph 24 *The bricks of the double leaves of the south end wall seen here above the ceiling timber project beyond the vertical wall and are smeared with mortar on their vertical ends. Darkened ashlar lines are visible in the grey render of the loft wall.*

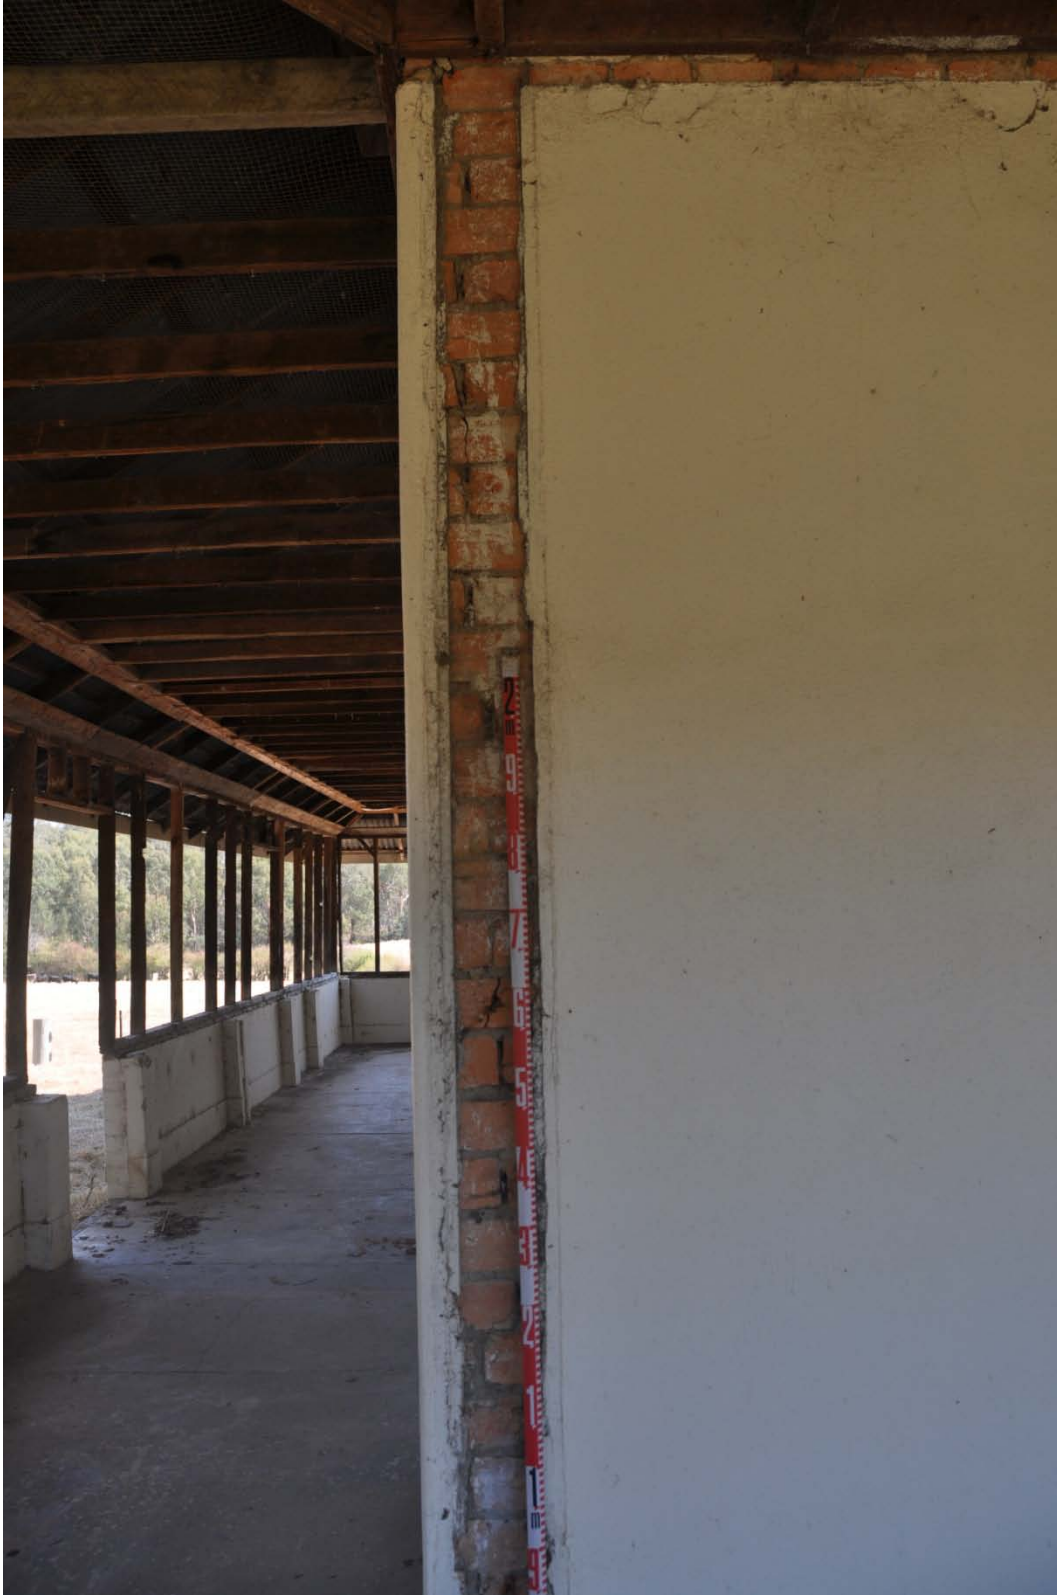
Photograph 26 *Seen here is the southwest corner of core rooms showing repair to create a corner in the 1950s. Staggered vertical placement of bricks and the absence of full half bricks at this corner indicate that it is a renovation and was not ever a corner. A "hard" mortar covers this renovation. Scale 20 cm intervals.*

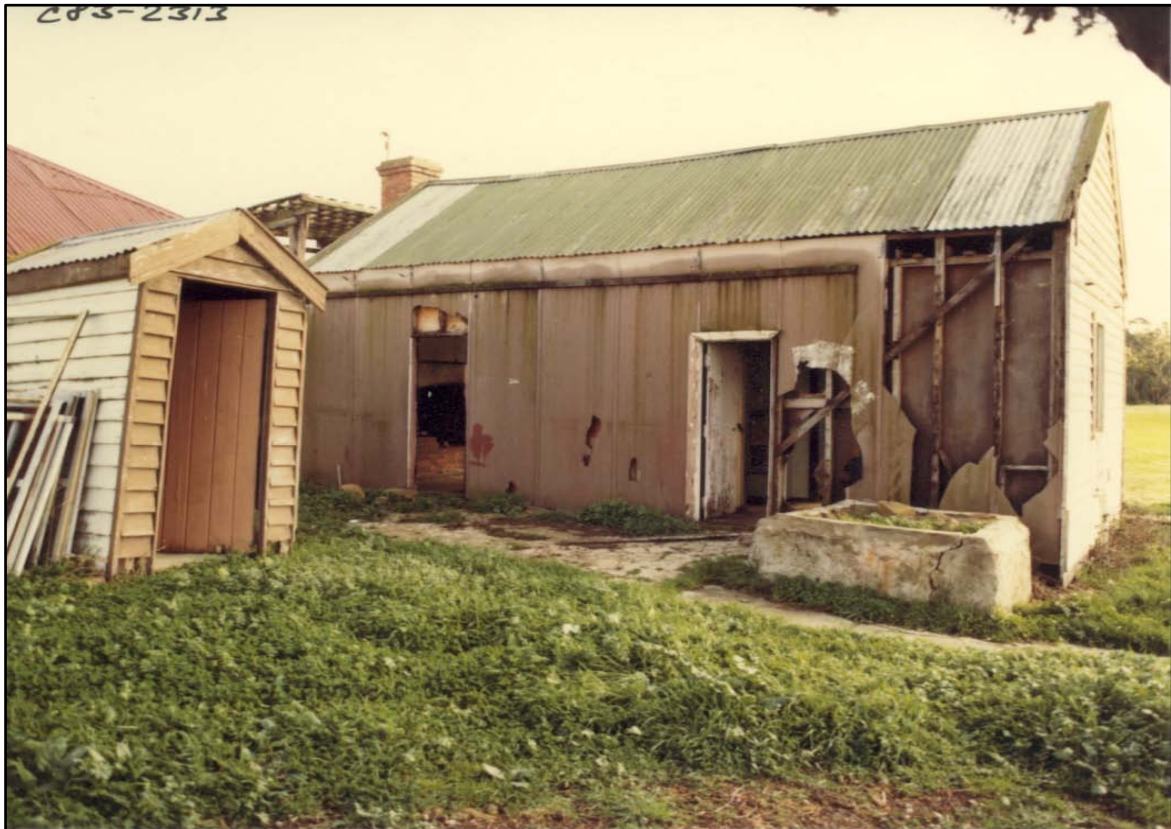
Photograph 37 *The kitchen in the early 1990s well after abandonment, with some evidence of vandalism. The horizontal stripe over the doors may relate to a skillion roof, as observed by G. Hawthorne.*

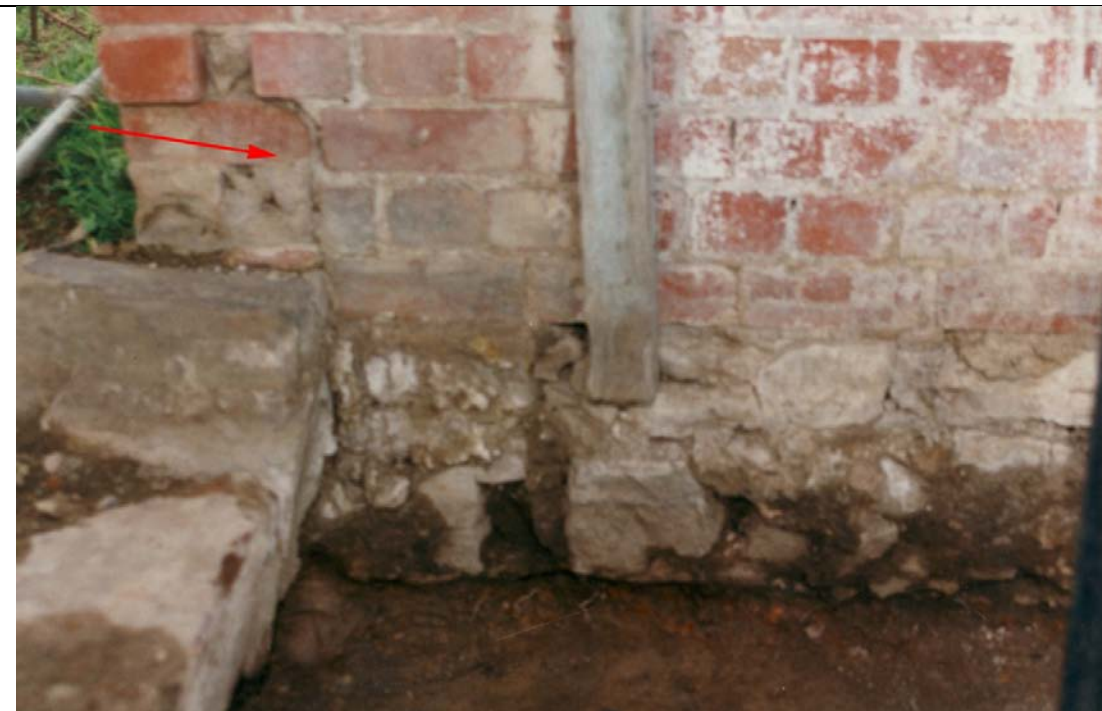
Photograph 48 *Recess in brick work (arrow) indicates homestead stone footing on left was built first and that its upper coarse is missing. Trench 2 showing base of chimney footing.*

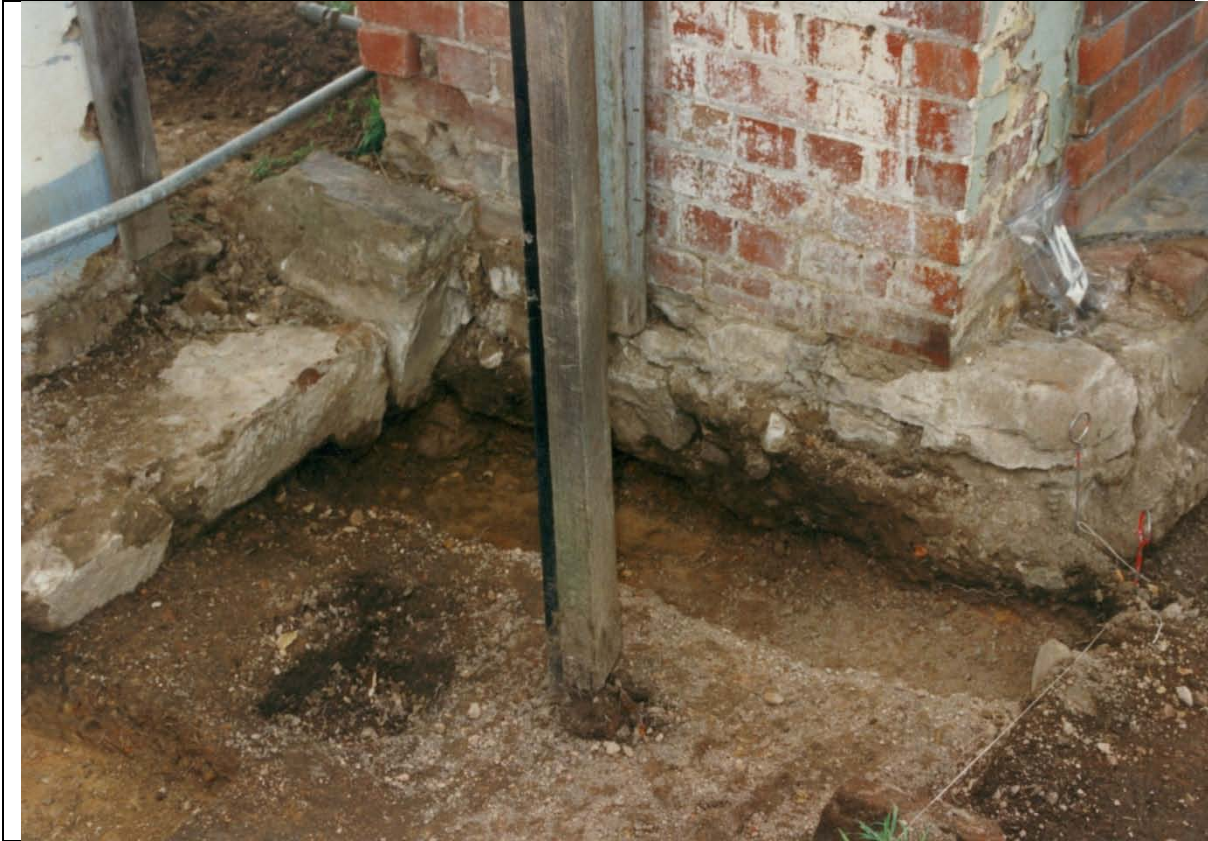
Photograph 49 *Seen here is the fully excavated Trench 2 showing a large square post hole next to the vertical timber post and the junction between the stone footings of the chimney and home-
stead (left).*

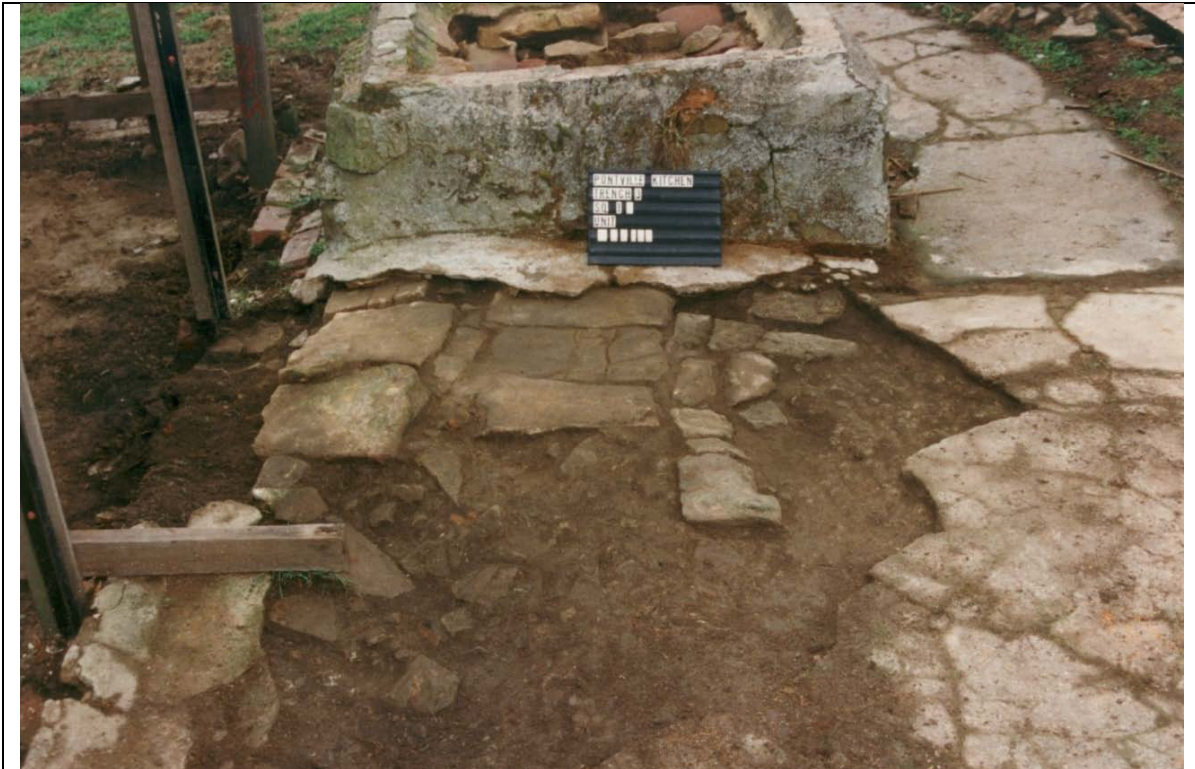
Photograph 51 Large blocks of stone, some rounded from wear, can be seen here below the thin mortar layer at the stone stand. A dilapidated spoon drain composed of concrete and brick can be seen between the path and the location of the kitchen wall, left.

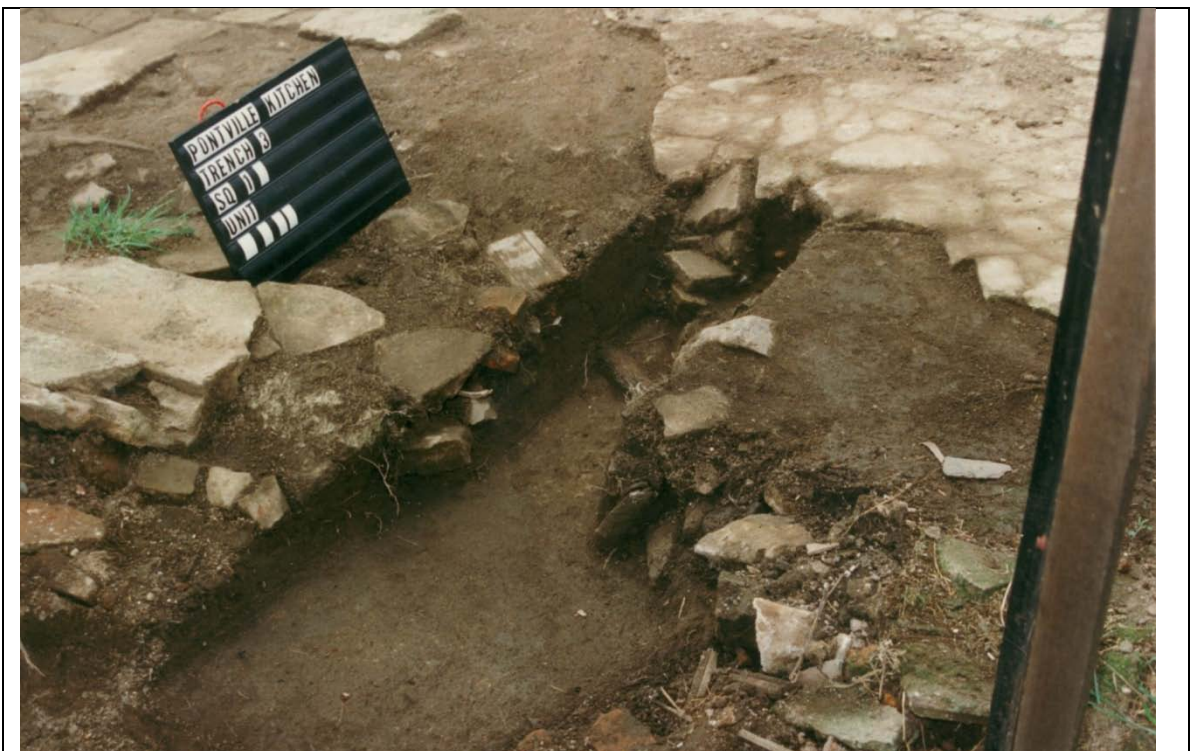
Photograph 52 Section through path alignment shows underlying rubble lying on undisturbed soil, Trench 3

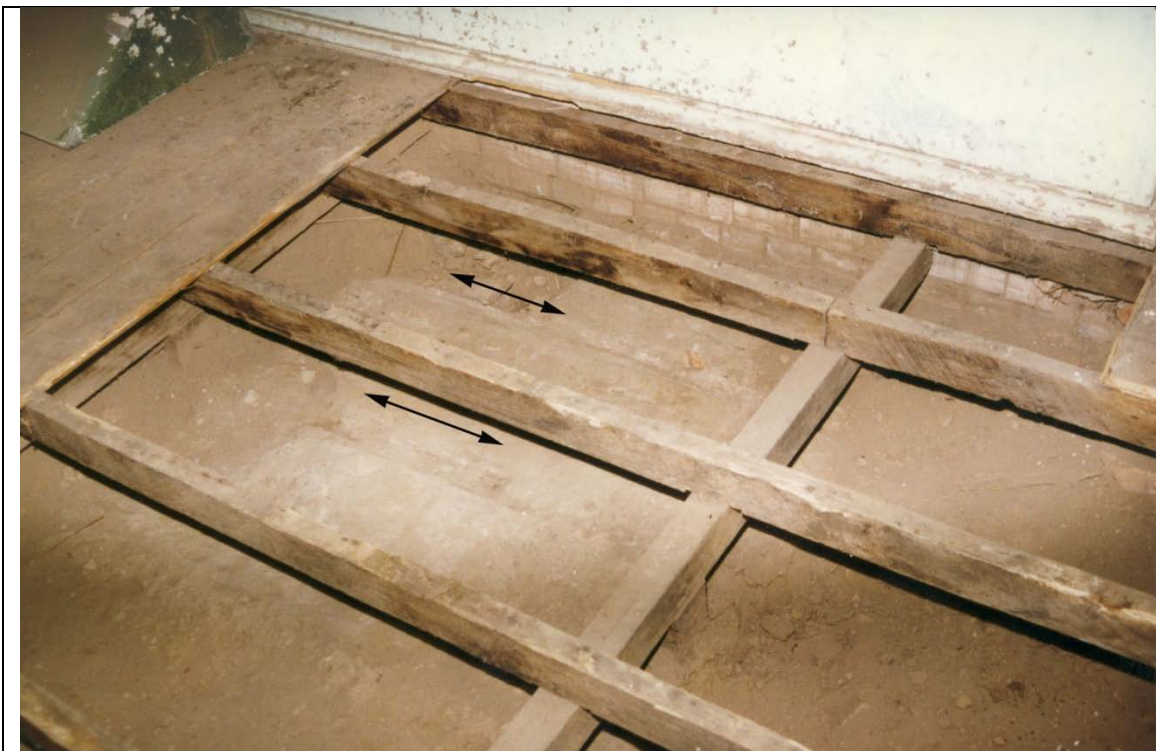
Photograph 60 *Found in the sub-floor area of the central room of Pontville in Trench 5 is a weak mortar pad (seen as a light colour between joists) on which are parallel linear impressions, arrows, made by former floor joists. These marks occur outside Trench 5.*

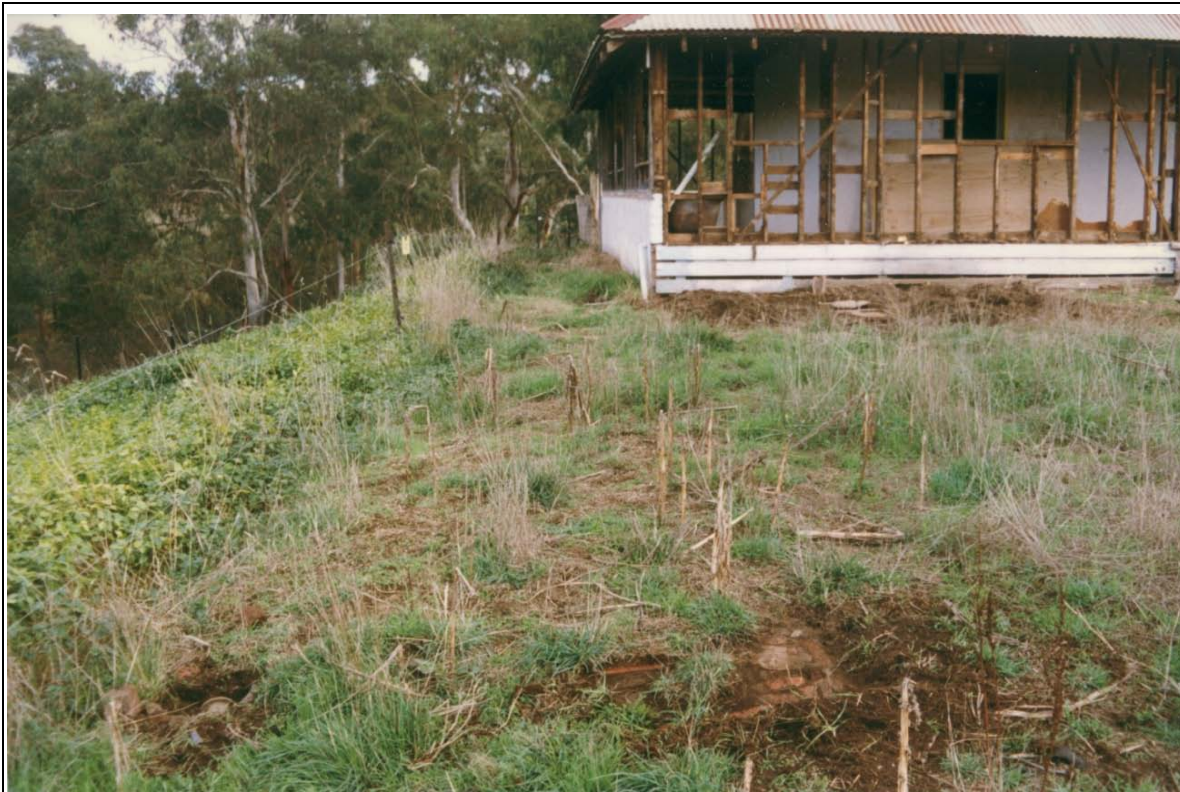
Photograph 63 View of South Garden and brick footing found in Trench 7, foreground. Agricultural and residential artefacts overlie the deposit but no systematic excavation was undertaken to delineate them.

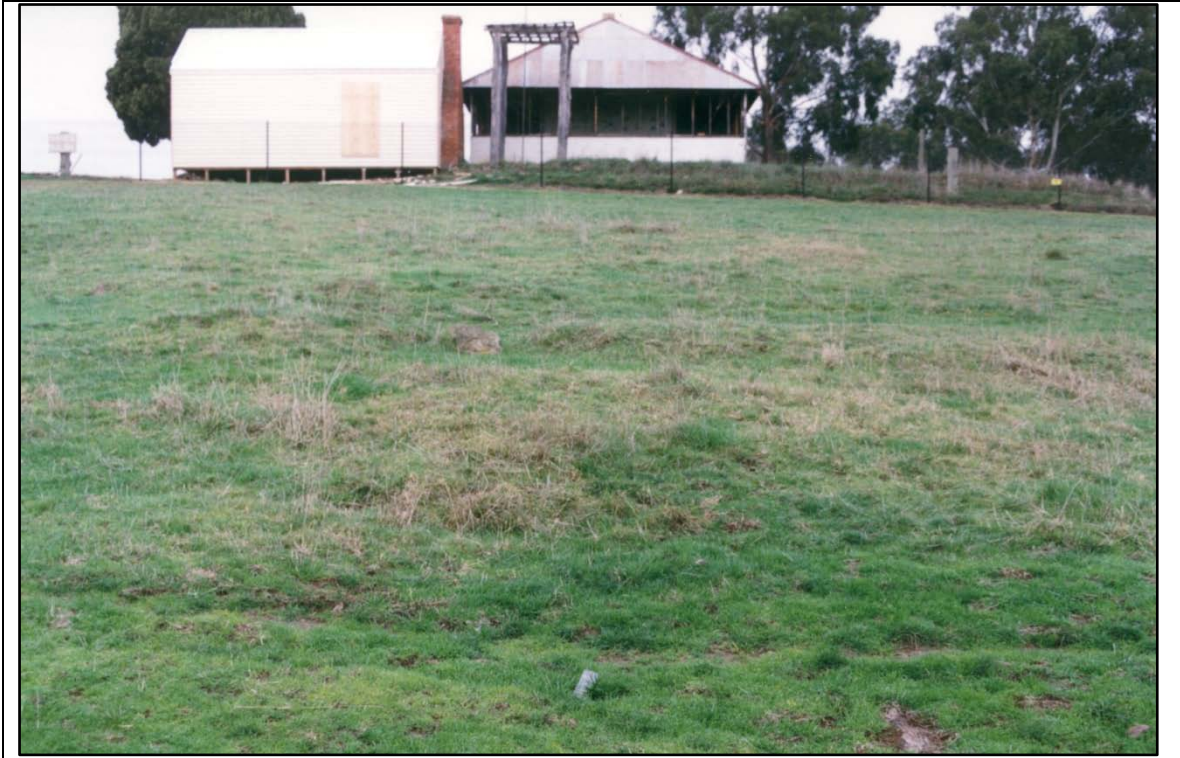
Photograph 64 *View of masonry ruins in Webster's hut track 55 m north of homestead, foreground. No excavation was undertaken here but the structure is believed to have been assembled in the 19th century and could belong to the original Pontville habitation. Sandstone blocks are strewn along the axis of the track, both to the right and the left of camera.*

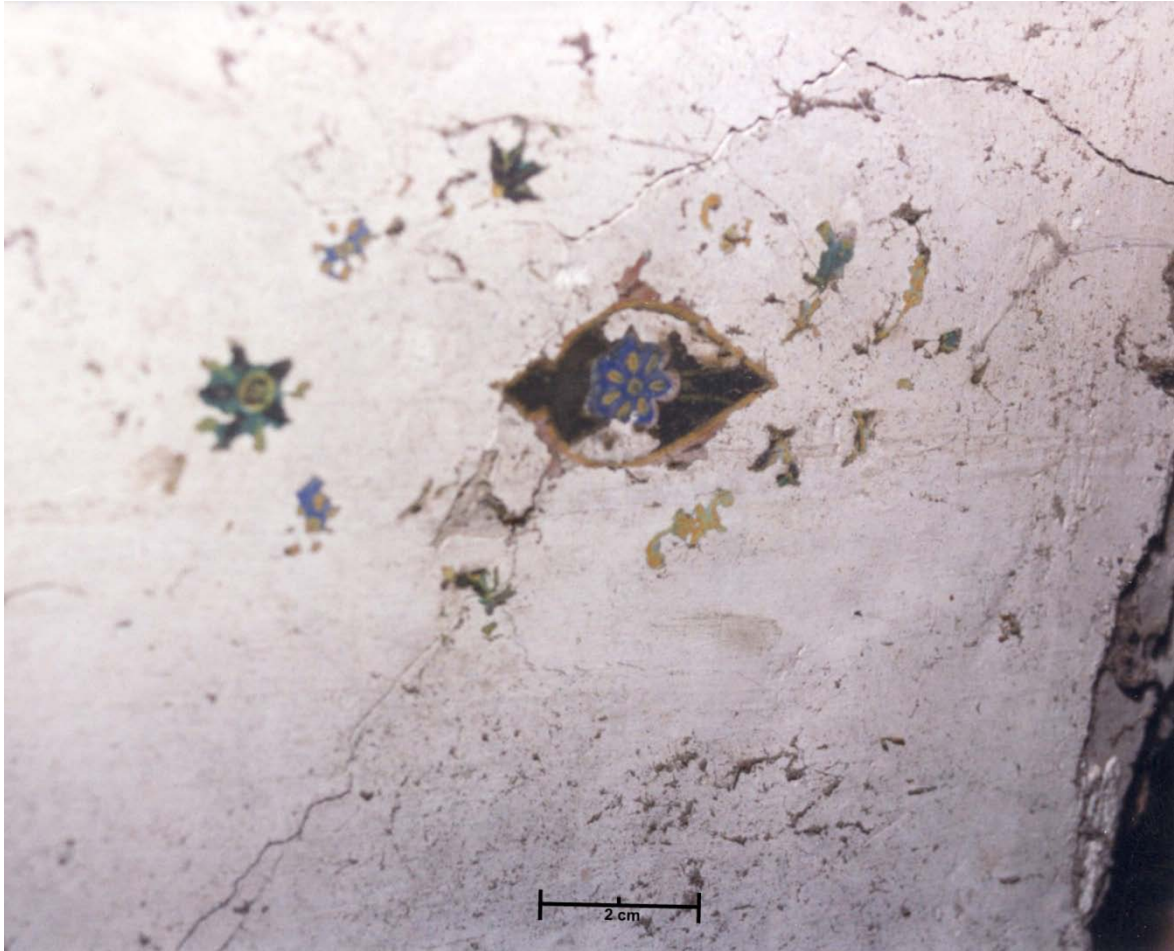
Photograph 72 Wall paper fragments on plastered wall over loft entrance. The scale is approximate.
