**MAJOR NEWMAN'S PONTVILLE:
FABRIC ANALYSIS AND ARCHAEOLOGICAL
INVESTIGATION OF AN EARLY COLONIAL HOME-
STEAD,
TEMPLESTOWE, VICTORIA
WITH
A COMPARATIVE STUDY OF SWEENEY'S
CULLA HILL, ELTHAM**

A report to Parks Victoria
June 2014

Roger Luebbers PhD
Consultant Archaeologist
August 1997
Revised June 2014

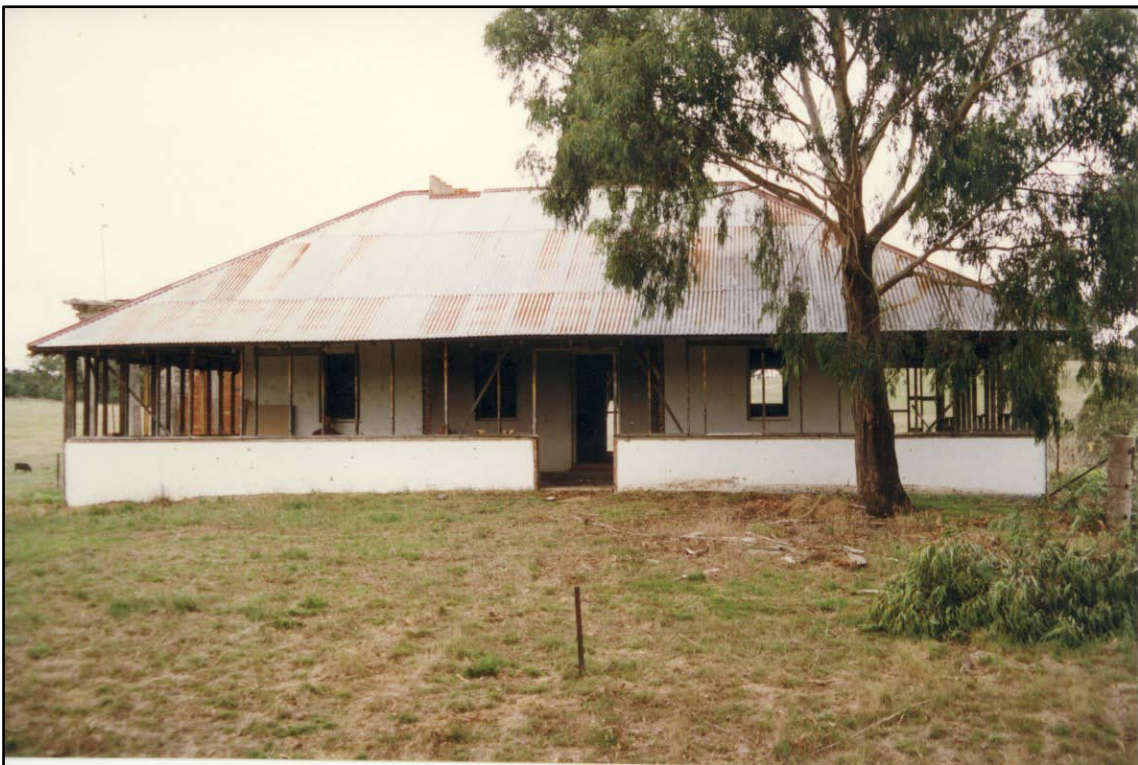
Photograph 7 *Front of Pontville homestead facing Mullum Mullum Creek 1997. The front terrace can be seen in foreground and the roof seen here is a recent rescue to keep the weather out.*

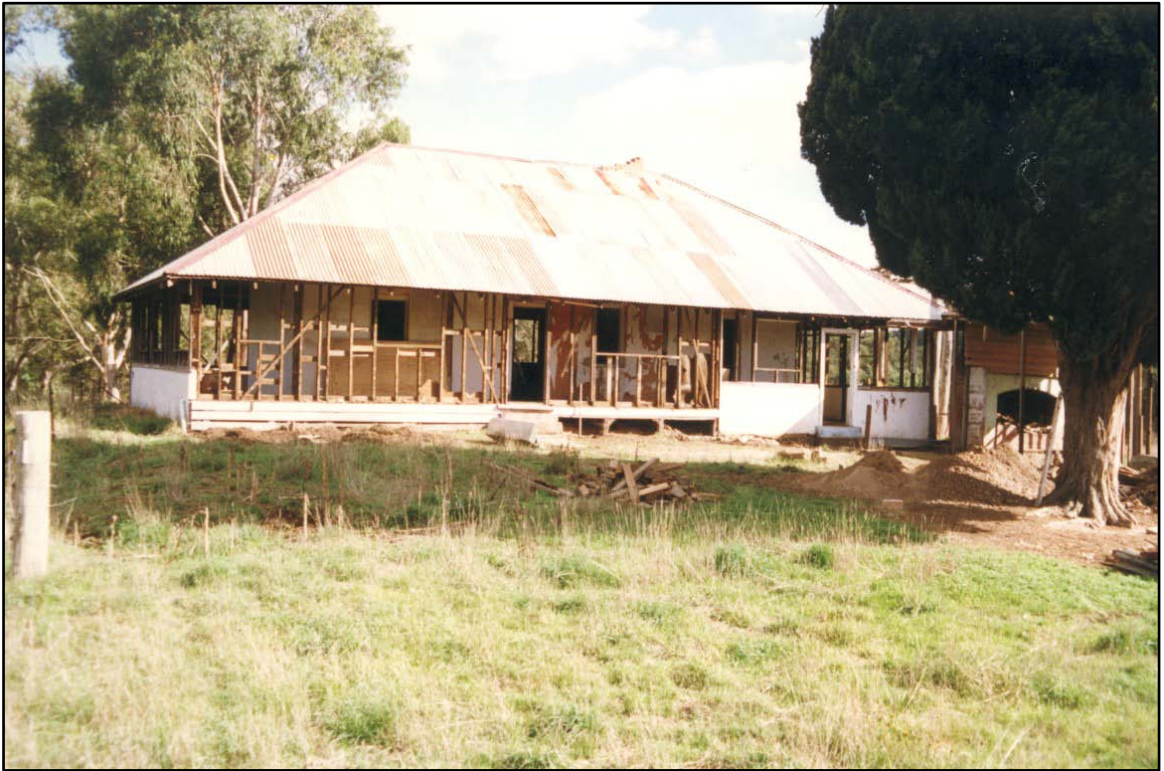
Photograph 8 *Rear of Pontville, 1997, during stabilisation program*

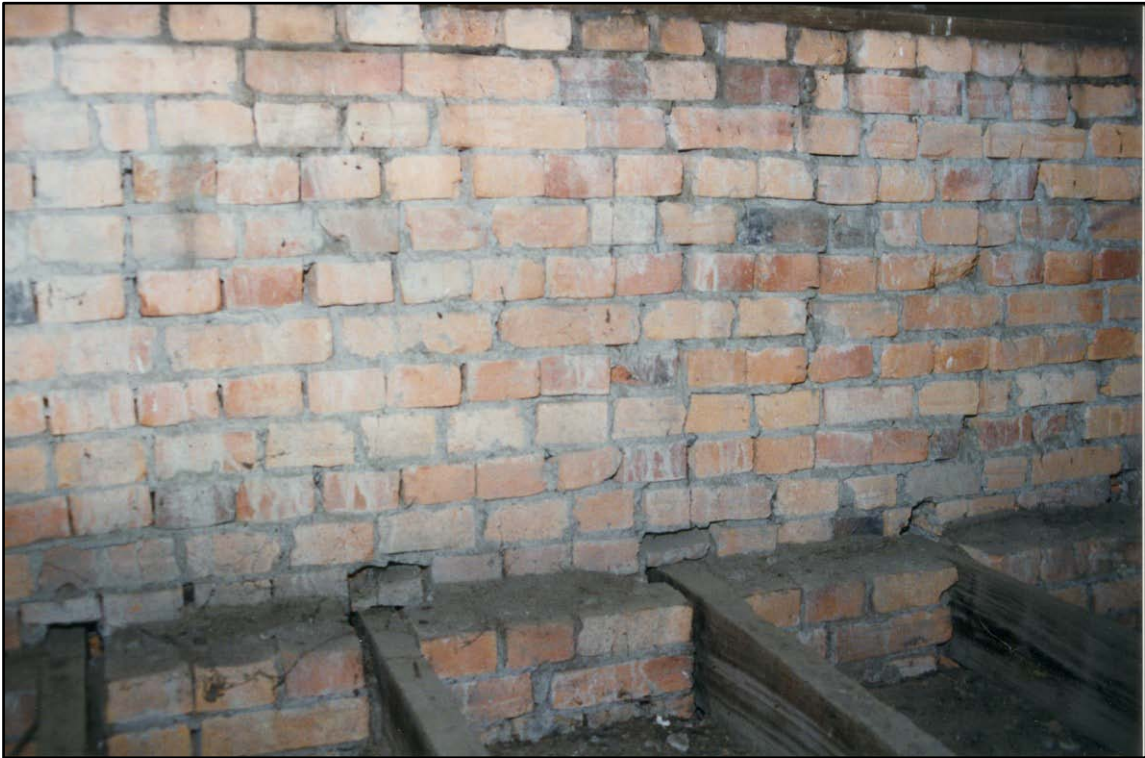
Photograph 12 *Limey wash appearing on these loft wall above the north room and on the double flued chimney are likely the results of rain washing wet mortar during construction; above north room, and hand-sawn ceiling joists inserted into walls.*

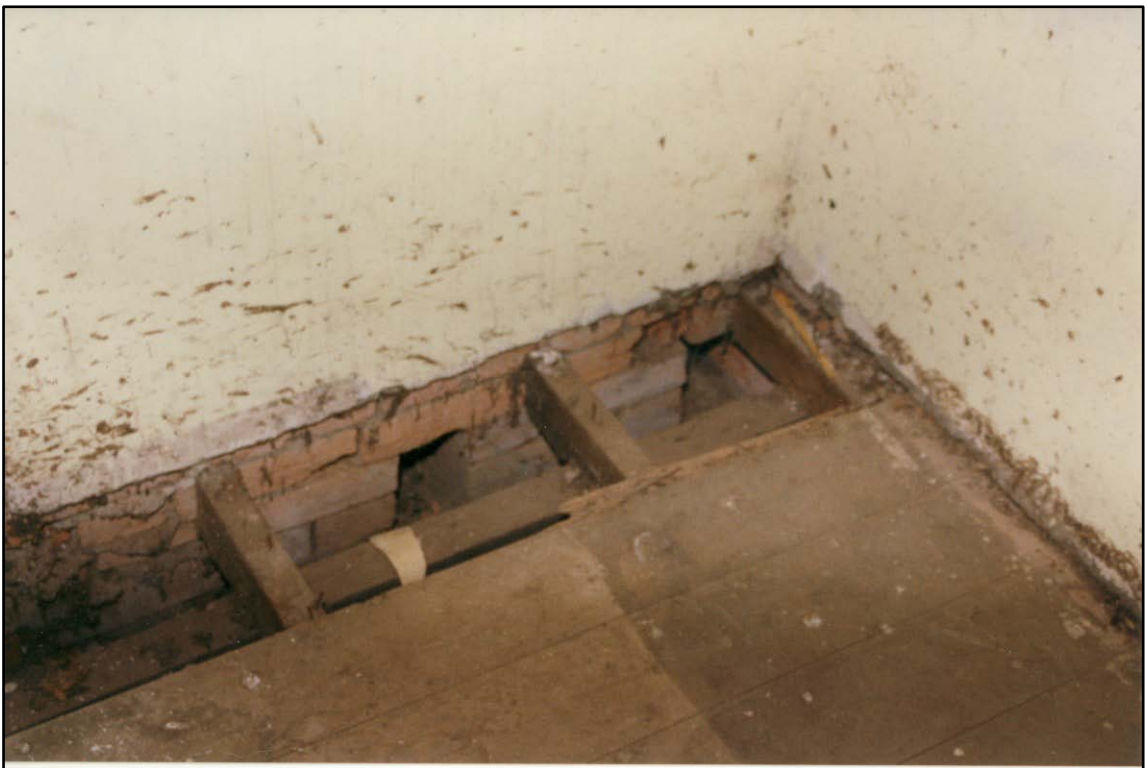
Photograph 13 *Sub-floor opening in north room showing joist insert holes in walls and underfloor vents.*

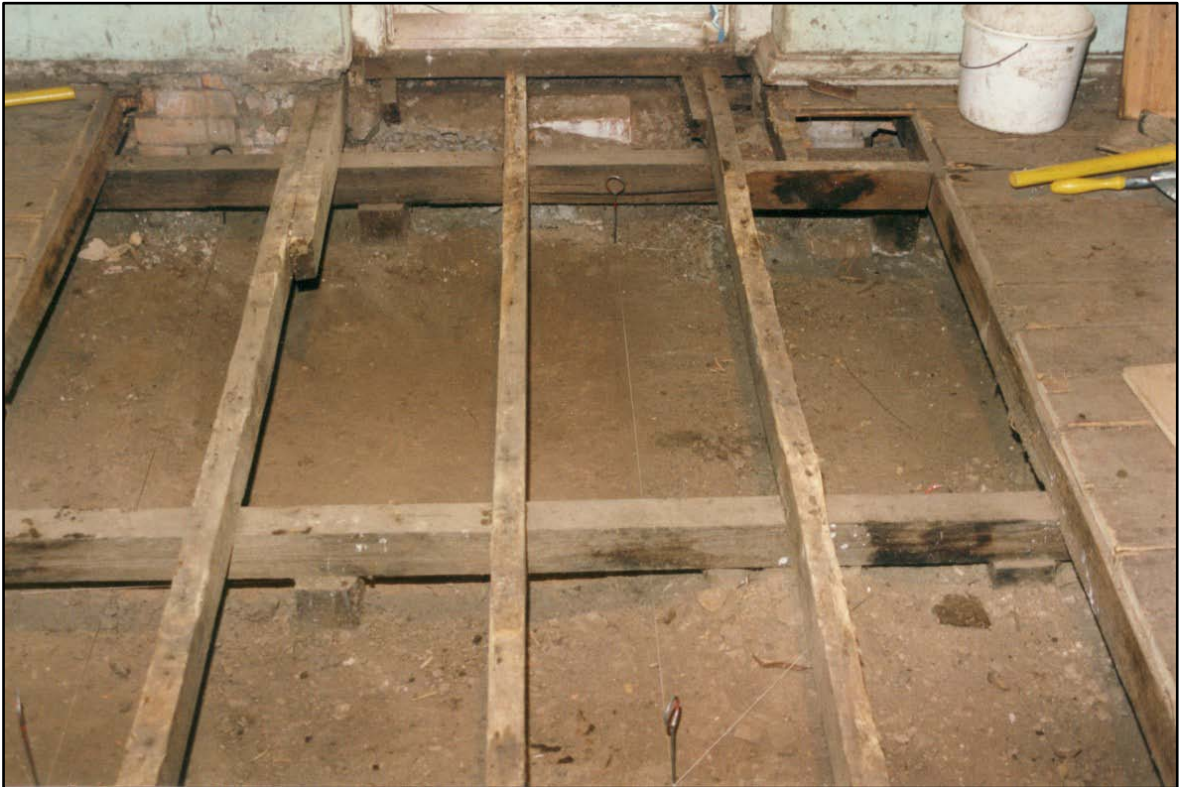
Photograph 14 *This floor opening in the central room reveals sub-floor deposits excavated in this assessment. The string line marks the excavation area of Trench 5. Floor level is raised above original installed by Newman. Lower front door fabric is visible at top of photograph.*

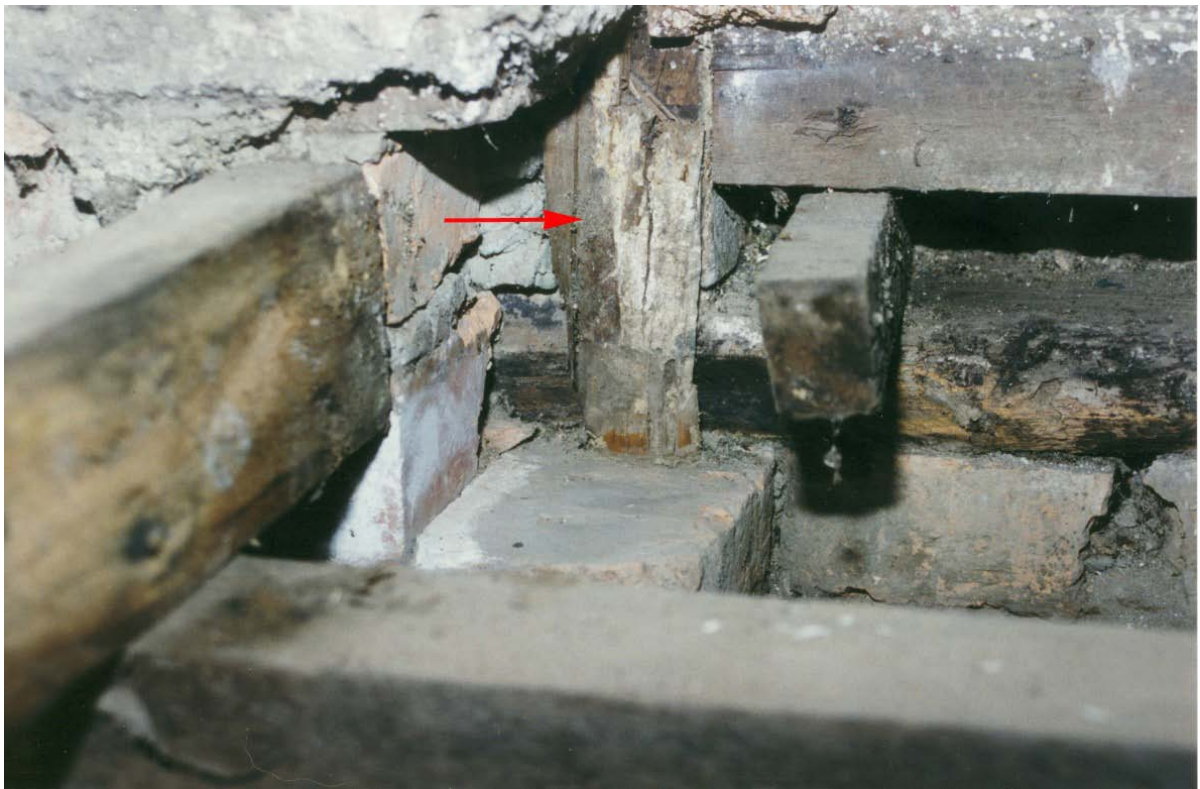
Photograph 15 *Close up of architrave fragment, arrow, at original sill in internal door jamb, front door, Pontville homestead.*

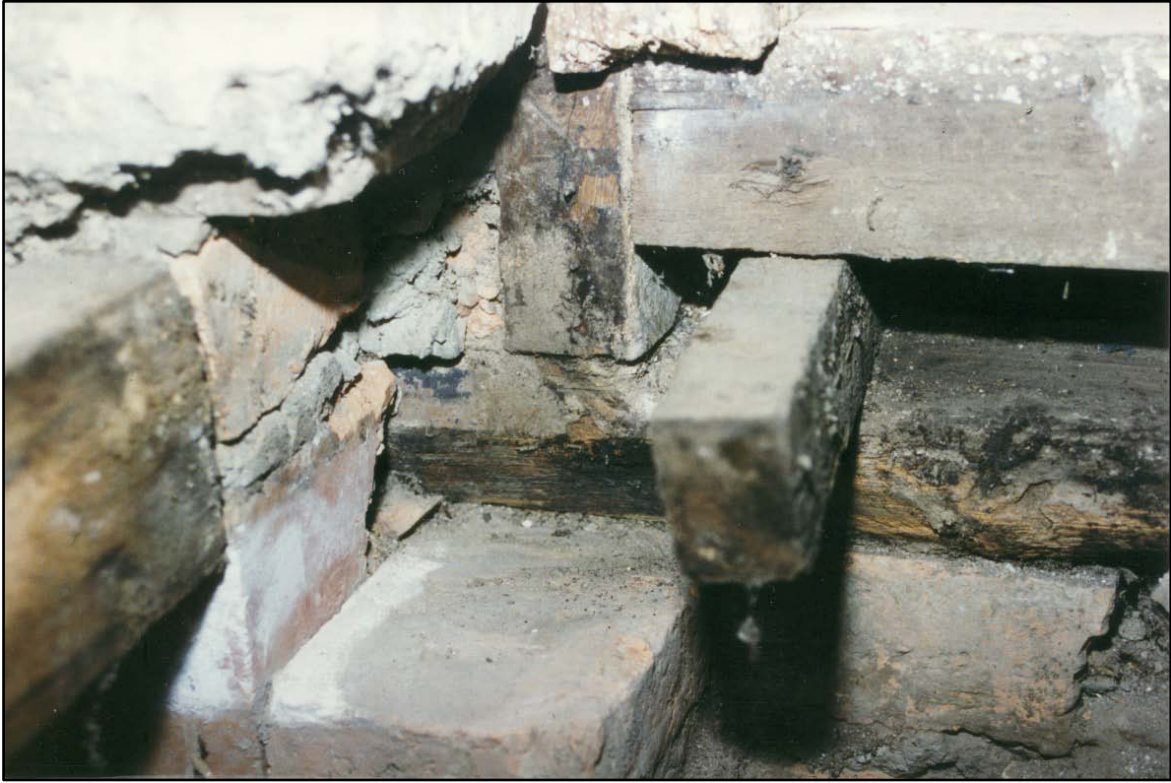
Photograph 16 *Detail of base of the front door jamb assembly with moulding removed and showing hand-sawn hardwood timber, with modern sill at top. Former sill resting on bricks indicates original floor height.*

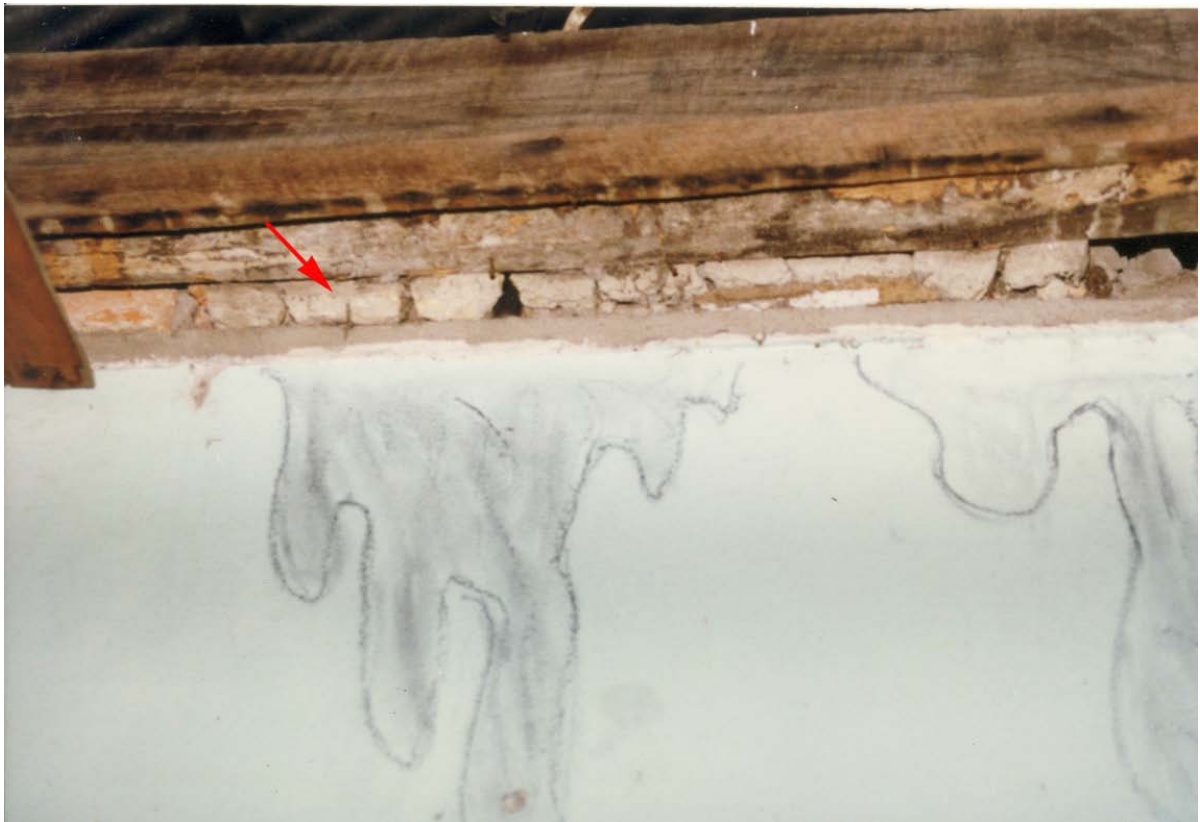
Photograph 19 *Remnants of first ceiling plaster (arrow), in situ, caught between ceiling joists and wall, central room, Pontville, S2.*

Two wall finishes were recovered in the demolition fabric beneath the floors of the house. The first, presumably applied at the time of construction, is a lime-rich sandy render which has been sized with animal hair to reduce cracking during setting. It is finished to a exquisitely smooth surface in a white lime plaster, although its appearance is often an off-white colour. This render is here referred to as "soft" render. The second render contains a hard setting cement (probably Portland Cement) and is generally gritty and not finely tooled— it is a post-1950s renovation. The only accessible traces of *in situ* render dating to the period of construction were found wedged between a joist and wall of the central room, Photograph 19 and **S2**.

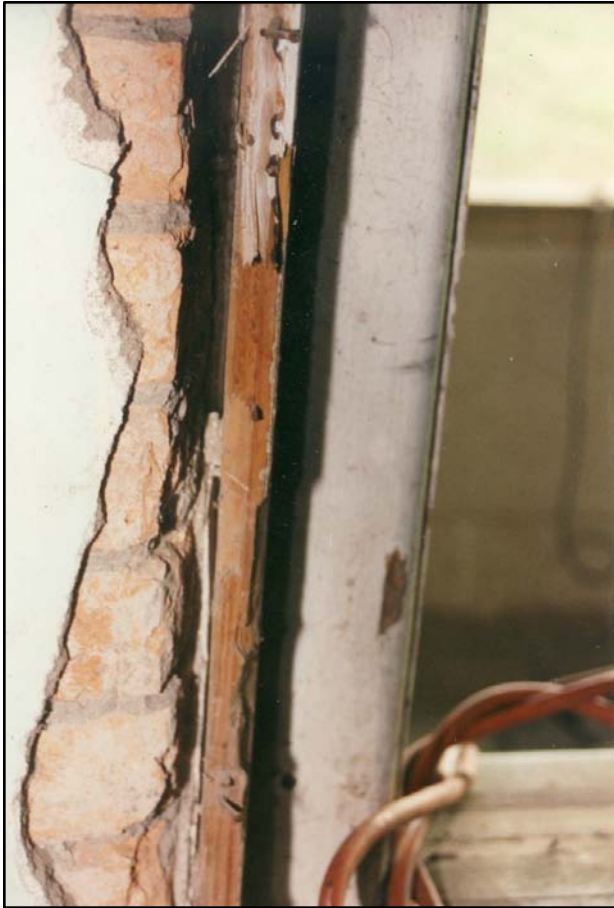
The “hard” wall plaster in the west window opening of the central room, Photograph 20, has broken away, exposing the interior cavity behind the window surround. Observed here is the wall fab-

ric consisting of hand-made bricks and the typical soft mortar, the remnant of the original white plaster adhering loosely to the wall, and the timber surround that joins the window frame. This timber is apparently sealed with a white paint. A 2-3 cm thick timber spacer with a square cross-section has been attached to the edge of the surround to extend it beyond the wall line the thickness of the wall plaster. It is to this strip that the missing extant architrave was attached. A similar spacer is attached to the surround in the north room, except that it is finished in a single bead for decorative affect. The surrounds in the other windows of the three core rooms are also finished in this manner. The assembly detail of the window surround is illustrated in Figure 6.

Photograph 20 Shown here is the timber window surround, beaded trimmer strip fragments, and attachment nails, with hand-made bricks exposed behind a renovation plaster.

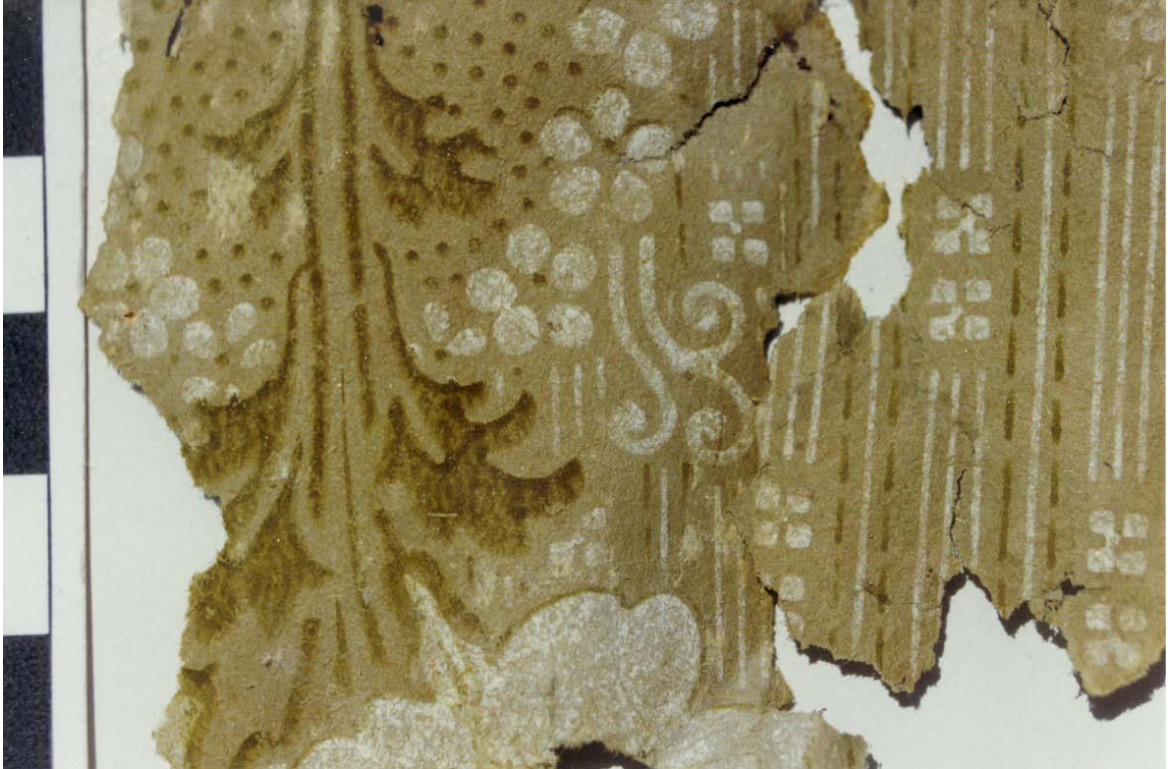
Photograph 22 *This is the first wall paper in the north room as found attached to a plaster fragment from sub-floor deposits. Scale in centimetres.*

- The first surviving paper, Photograph 22, (**S22a**) in the south room is a stylised floral motive separated by bands of parallel white lines and serial dots. Murphy considers this a typical Victorian pattern belonging to the mid-19th century, probably earlier than 1860. The lime washes were covered in the three core rooms by a succession of wall papers. The second paper, Photograph 21, (**S22b**) is a primitive stripe of abstract design based on a floral motif with a contrasting silver band against a white background.

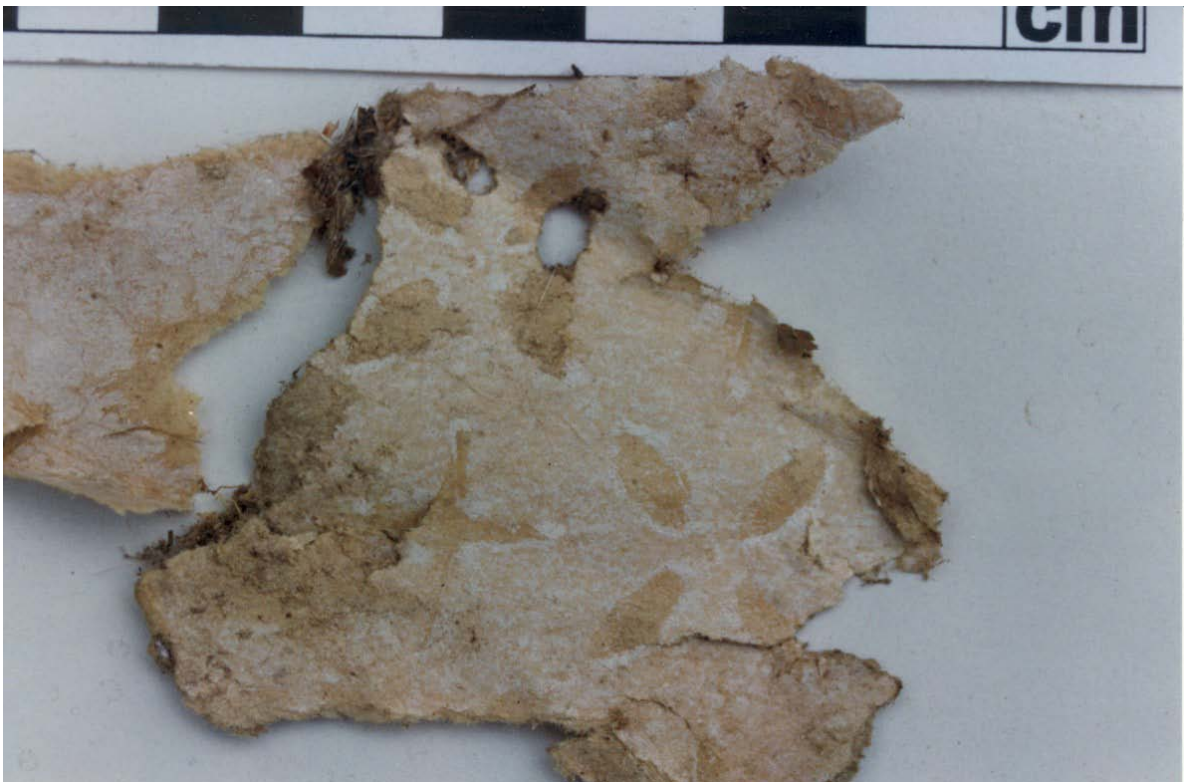
Photograph 23 *Wall paper removed from the north room sub-floor area.*

- Another paper, from the north room, Photograph 23 (**S25**), was recovered over a white lime wash over plaster. It features a four petal flower outlined in a shiny silver against a beige or ochre background.

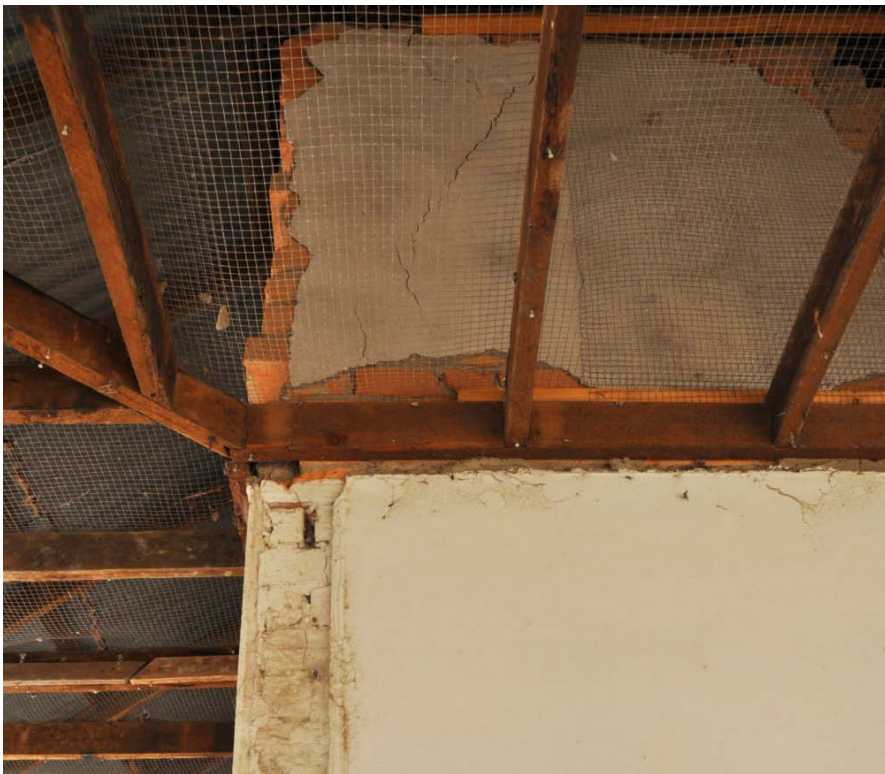
All four external corners of the core rooms are visible and possess identical fabric detail, although some bricks are painted and 1950s render covers much of the joins. For this assessment, the southwest corner is used to illustrate fabric relevant to all four. The end masonry of two leaves is broken away in the vertical wall section above the extant ceiling clearly exposing the internal masonry of the loft section of the wall, Photograph 24. A renovation render covers the wall from this point to the floor. A gray render with ashlar lines adheres to the exterior surface of the loft masonry and terminates abruptly at the wall line where it comes in contact with the exposed double brick wall of the south end room. Minute projections of this render turn outwards from this junction suggesting that the render once continued at a right angle to a masonry wall that no longer is present. Similarly some of the brickwork of the common wall projects well beyond the vertical wall line of the verandah, Photograph 25. Mortar is smeared on the vertical faces of many of these exposed bricks, suggesting a continuation of the masonry beyond the vertical wall line of the core rooms. These all indicate that the external leaf above the ceiling of the south room continued past the wall line at the time they were modified in 1950.

Photograph 25 *The exterior bricks of the double leaf south room seen here from the end room project well beyond the vertical wall at staggered spaces and are covered by render.*

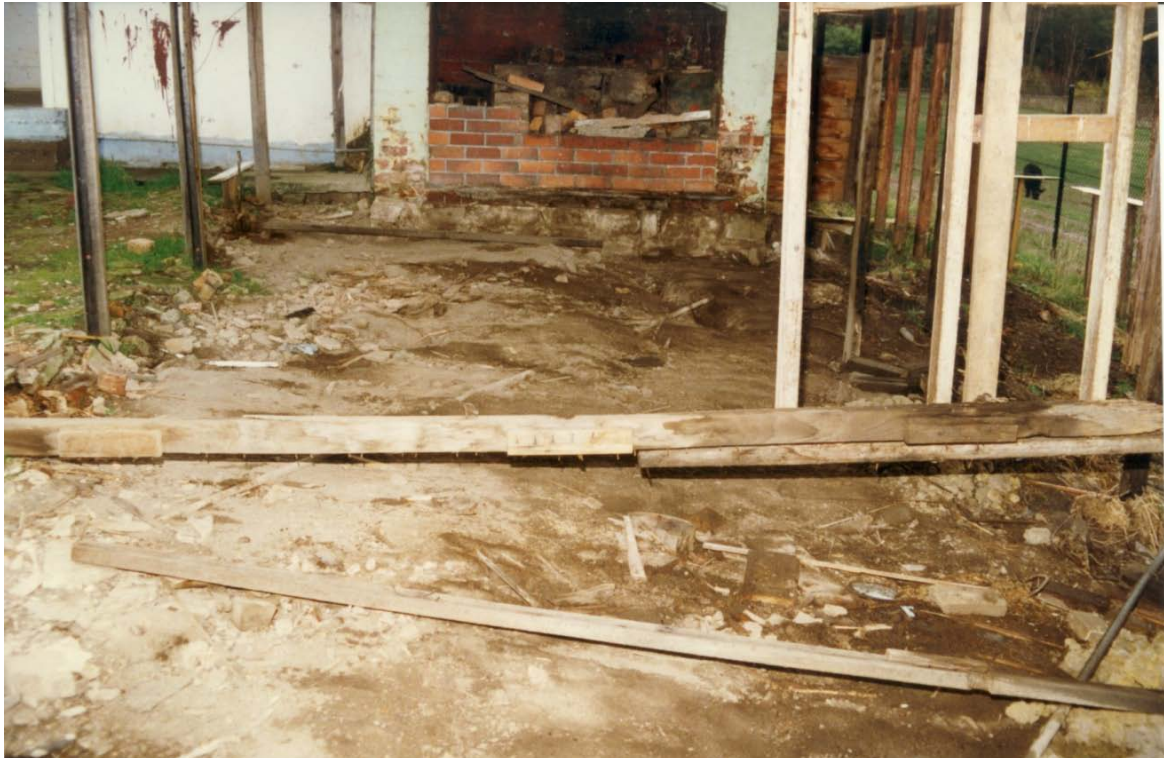
The detached kitchen at the commencement of this investigation, Photograph 36 & 37, was a derelict skeleton of the former structure - major elements were missing from the frame and floor, and a majority of internal lining and roofing iron had been removed, including almost all subfloor support structure. Remnants of timber lining were present in the upper reaches of the divider wall and ceiling. The vertical timber frame elements are supported by steel droppers as a rescue measure and some are free swinging without attachment to lower frame elements. The remnants of a built-in cabinet is present in the northwest corner and presumably similar storage was incorporated on the opposite side of the chimney, as can be confirmed by earlier photographic coverage.

At the time of the field investigation, the kitchen fabric was in grave state of disrepair and the structure was at risk of being blow over by wind gusts. Accordingly care was taken to ensure that staff were not placed in danger or that works undertaken did not destabilize the fabric without assistance of an additional rehabilitation budget.

Photograph 36 *The detached kitchen in 27 May 1997 at the start of this project.*

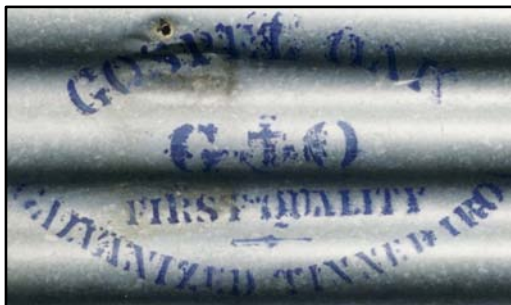
- There are no empty nail holes to suggest the sheeting is second hand.
- Roofing nails with lead heads and wire drawn shanks were used to attach CI sheets.
- The manufacturer's mark on the sheets of Gospel Oak is illustrated in Photograph 38, and described by Lewis (1994).

Photograph 38 *This brand of Gospel Oak was recorded on galvanized roofing sheets to the kitchen.*

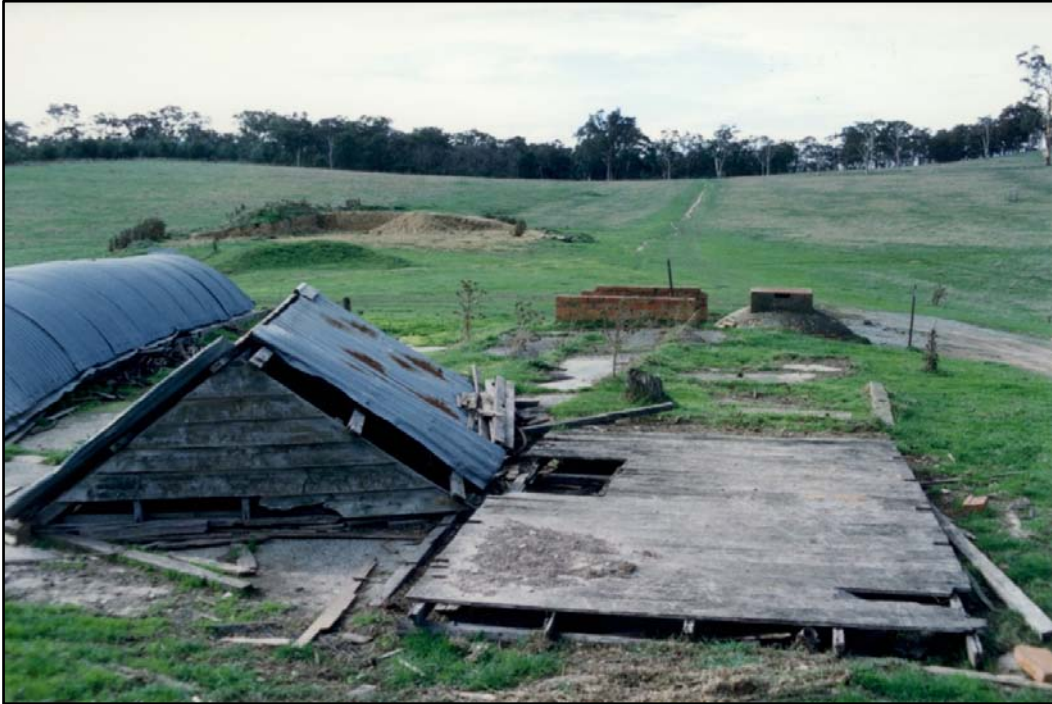
The dairy survives as remnants of a timber framed 8 x 10 foot shed overlying concrete floors of the milking area and a second curved corrugated iron roof that rests over the edge of the concrete yard without walls, Photograph 39. A derelict refrigeration unit and steel rails mark the animal enclosure area and a brick roofed circular water tank is located just outside one corner of the former yarding area. One of the concrete slabs is identified by George Hawthorne as the one he helped pour in 1938-40 and water for cleaning and washing was pumped from the nearby brick water tank.

Photograph 39a Shown here are the remains of a timber shed and concrete platform and dome- roofed brick water tank of the Pontville dairy and equipment storage shed, described by George Hawthorne, Section 2.4 above. Photographed 1997.

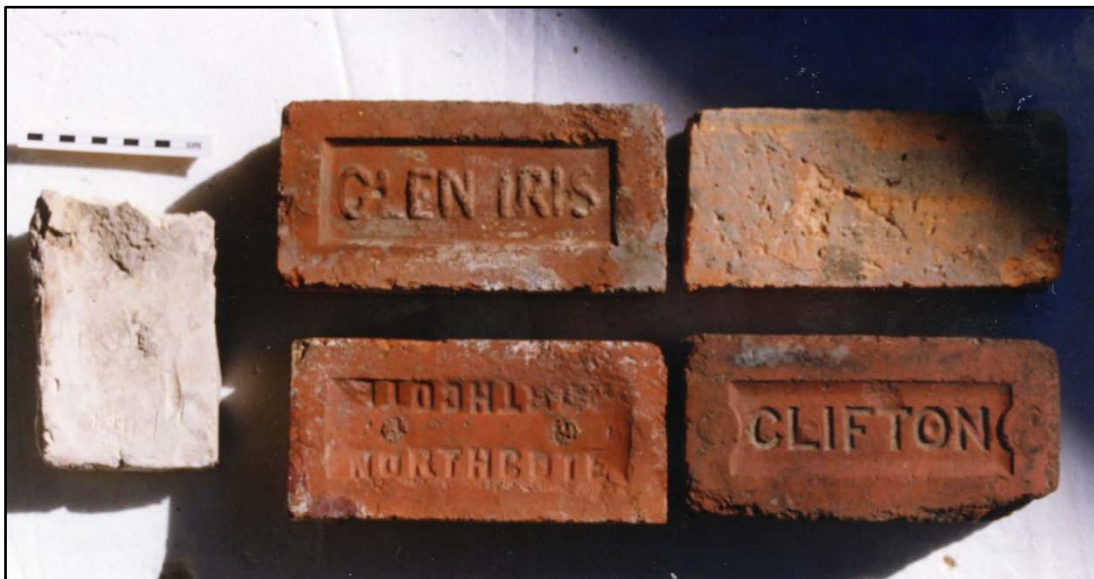
Five bricks are recovered from Pontville masonry, Photograph 40. The first (220 x 110 x 62 mm) is a made in a slop mould without a frog in a generally uniform pale orange colour, although some examples in the loft are considerably darker on one edge from uneven firing in the kiln. A linear hack mark in the form of a raised bulge runs the length of the stretcher or long face and there are no other manufacturing marks. A dry pressed red brick (230 x 110 x 75 mm) with the name "Northcote" embossed twice on a single frog is manufactured by the Northcote Brick Company beginning in 1882 (Lemon 1983) as the second brick type at the homestead. This company began operating in pits in 1873 trading as the Northcote Patent Brick Company but the firm introduced the Hoffman kiln in 1882³⁷ and this brick most likely was used to construct the kitchen after this date. All of the fireplace and chimney in the detached kitchen is made from this brick, as are some spoon drains, and a footing of a small structure south east of the homestead discussed below. The third brick (no measurements taken) is a red dry pressed brick with the name "Clifton" embossed on the frog, manufactured by the Clifton Brick Company. Although the early production dates for the Clifton Brick Company in ca 1890-1910 was erratic, it is believed to have become more viable after ca 1930 (Carroll & Rule 1985, Clifton Brick Company 1935). The underground water tank at the Pontville dairy incorporates this brick throughout its above ground fabric. The fourth brick (235 x 115 x 80 mm) is another red dry pressed brick with the name "Glen Iris" stamped in raised letters across the frog. This company started brick production in 1913³⁸ at a Thornbury clay pit after amalgamating with other manufacturers. It is incorporated in the renovation fabrics at Pontville attributed to the upgrade undertaken by Leslie Paddle after his purchase in ca 1950. The fifth brick type (**S10**, fragment) is exceedingly rare in the assemblage and remains somewhat of a mystery. It is a hand-made undersized off-white brick about 45 mm thick with a fine texture paste that is not uniformly mixed as viewed in fragments. All surfaces are slightly undulating and it does not possess sharp corners. It is present in small numbers in the firebox (repaired?) of the central room, the footing to one hearth stone, and was found under the floor in the north room. Its position in the construction history of Pontville has not been established by this study, but it certainly belongs to early fabric in the building and may have been intended as a firebrick in the fireplace.

Photograph 40 *These are the five types of bricks found at Pontville. The orange brick, upper right is the hand-made Pontville brick and the white cream coloured brick on the left is also hand-made and was incorporated in the Pontville original construction. Scale in centimetres.*

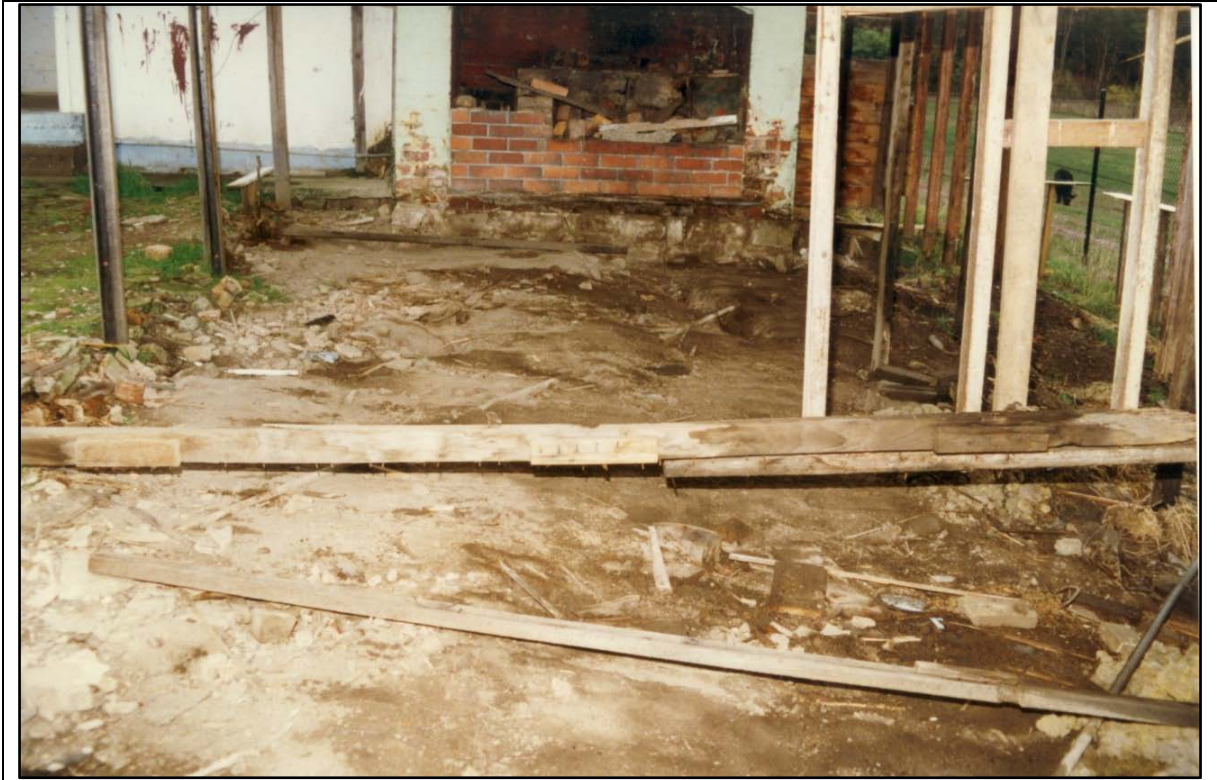
Trenches 1 & 2 were excavated to examine interior deposits and structure of the kitchen and any evidence of earlier fabric, Photograph 41. Demolition debris is strewn over the sub-floor surface at the start of works included food and animal bone, wood off-cuts, gravel, wood fragments from the timber structure, metal tins, broken glass drink bottles, and a mixture of concrete and brick fragments, metal pipes, and paper wrappings. The historical significance of most of this material could not be evaluated without considerably more detailed research but where dates could be assigned from simple inspection were contemporaneous with the 20th century habitation. Except where specified in the artefact inventory, Appendix 7, this material was considered too fragmented or decayed to warrant further study. A single stump and no other floor fabric remained inside the building.

Photograph 41 *Trench 1 before excavation commenced in detached kitchen, Pontville*

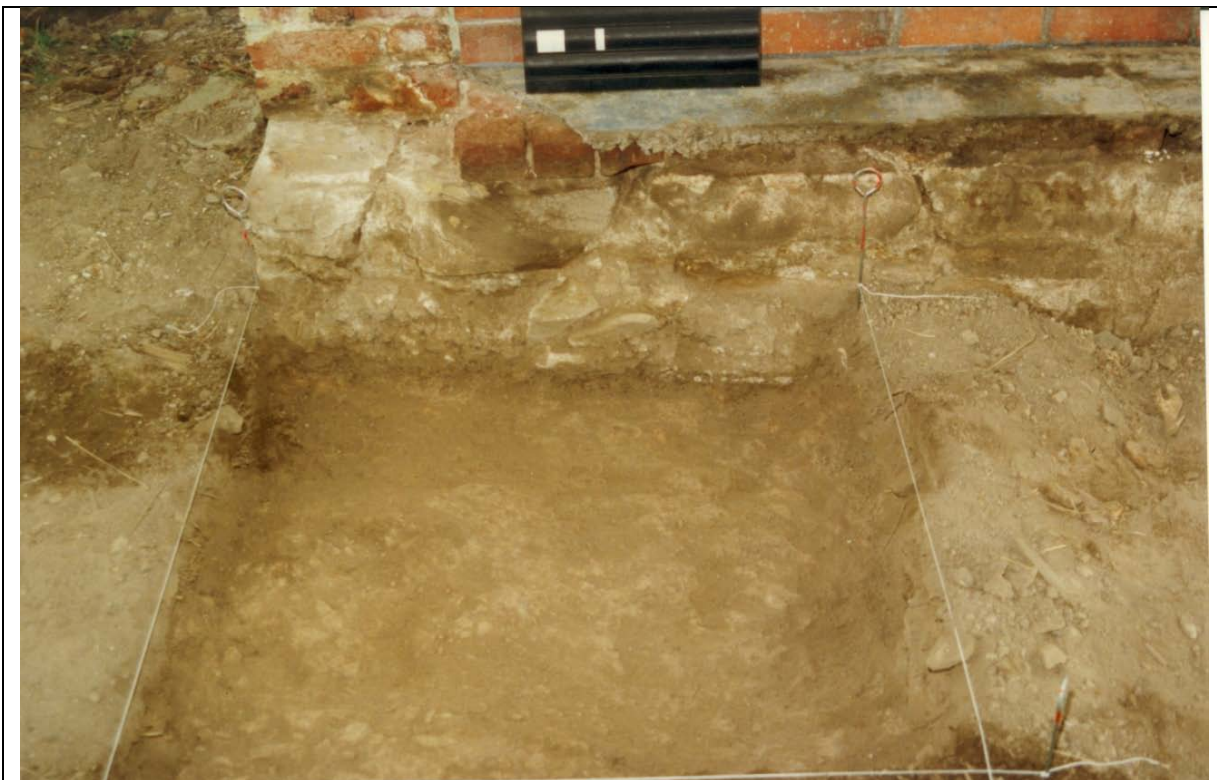
Measuring 1 x 4 m and divided into four one metre squares, this trench exposed the fireplace footing inside the structure and associated sub-floor area in room 1 of the detached kitchen, Figure 8 Photograph 42 & 43. Squares 1 and 3 & 4 were each excavated in three layers, exposing artefact sterile clay in each case at the base. Square 2 encompassed extensively disturbed sediment and was ignored.

Photograph 42 *Trench 1 Square 1, at base of excavation*

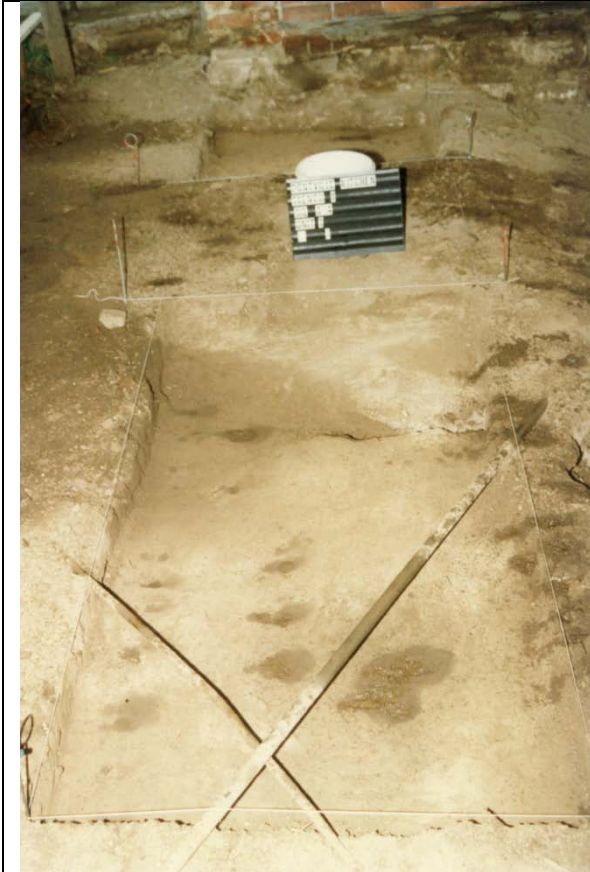
- No structural elements of the extant framework or former structures were detected.
- Significant disturbance has occurred from animal burrowing across the entire footprint of the building. Surface runoff, possibly accelerated by failed gutter and surface drains, is widely evident. Rabbits and dogs are the principal culprits. Noticeable infilling of burrows by rubbish, possibly aided by water transport but including deliberate human disposal is indicated.
- The stone footing to the chimney is composed of a pad of selected flat sandstone blocks which are joined by mortar (**S4**) in tight fitting arrangement. This stone lies on a compact bed of small rock rubble containing fines that may include lime. No lower infill was detected.

Photograph 43 Trench 1 Square 3 & 4 excavated to base

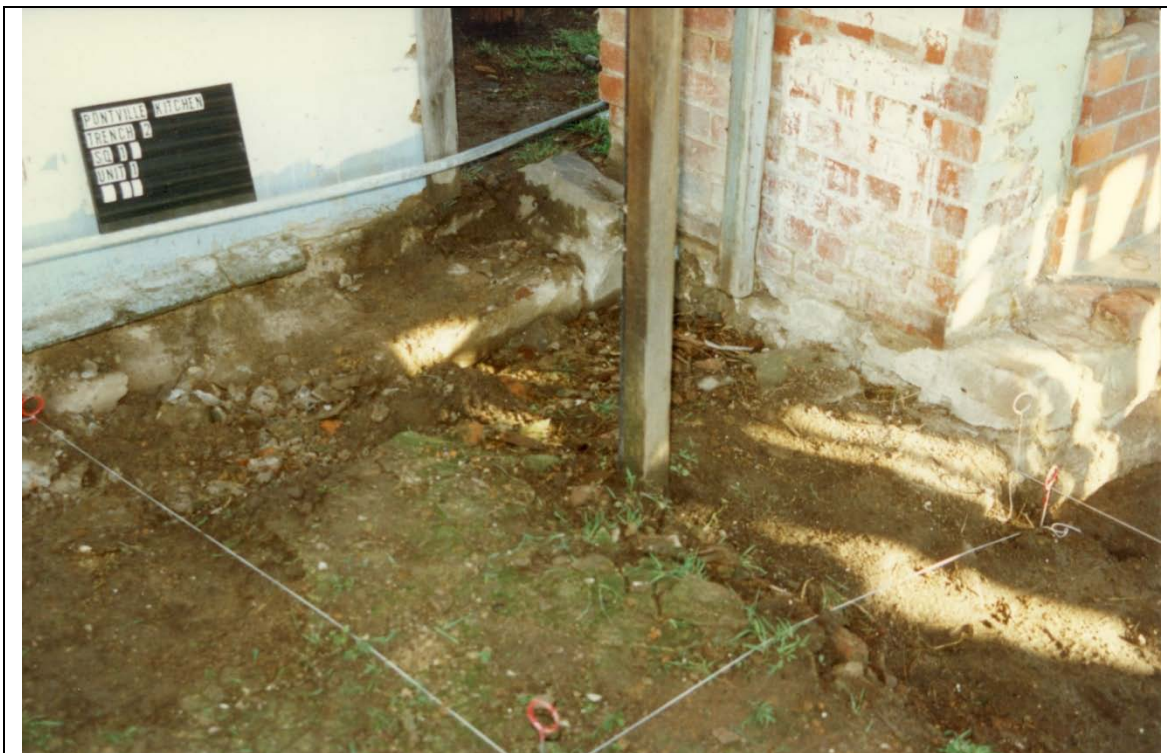
Measuring 1.0 x 0.15 m this trench is positioned at the SW corner of the detached kitchen to expose the chimney base, the homestead footing of the north end room, and a concrete slab to show relationships to the homestead footing and to identify earlier fabric, Photograph 44. This trench is located at the closest junction between the two buildings where renovations to form the dwarf wall in the 1950s resulted in the abandonment of the original stone footings of the homestead, Photograph 46. Units 1-10 were removed separately as subdivisions of this 1.5 metre square trench. These were not superimposed sedimentary units but were considered individual depositional features across the trench floor, see excavation notes in project files. A concrete slab abutting the end wall and associated with the 1950 renovation was removed to further examine the stone footing at the corner of the house. Unit 8 is wall rubble ending level of the footing base and Unit 9 is a solid clay unit beneath the footing.

- A slab of concrete ca. 40 mm thick abuts the verandah masonry and extends to a point just beyond the gutter drip line from the house corner to the steps entering the north end room. It slopes slightly away from the house covering the former house footing. It could be intended as a footpath between kitchen and house but its narrow width makes this interpretation less likely. It more likely is intended to shed water away from the house towards surface drains along the adjacent south wall of the kitchen. Their failure, as shown in Trench 3, may explain excess surface run off beneath the kitchen and hence significant erosion and the transport of materials under the kitchen floor. Fragments of roofing slates were found immediately below the underside of the slab when it was removed (see project collection).

Photograph 44 Trench 2 laid out with string after removal of concrete slab over house footings.

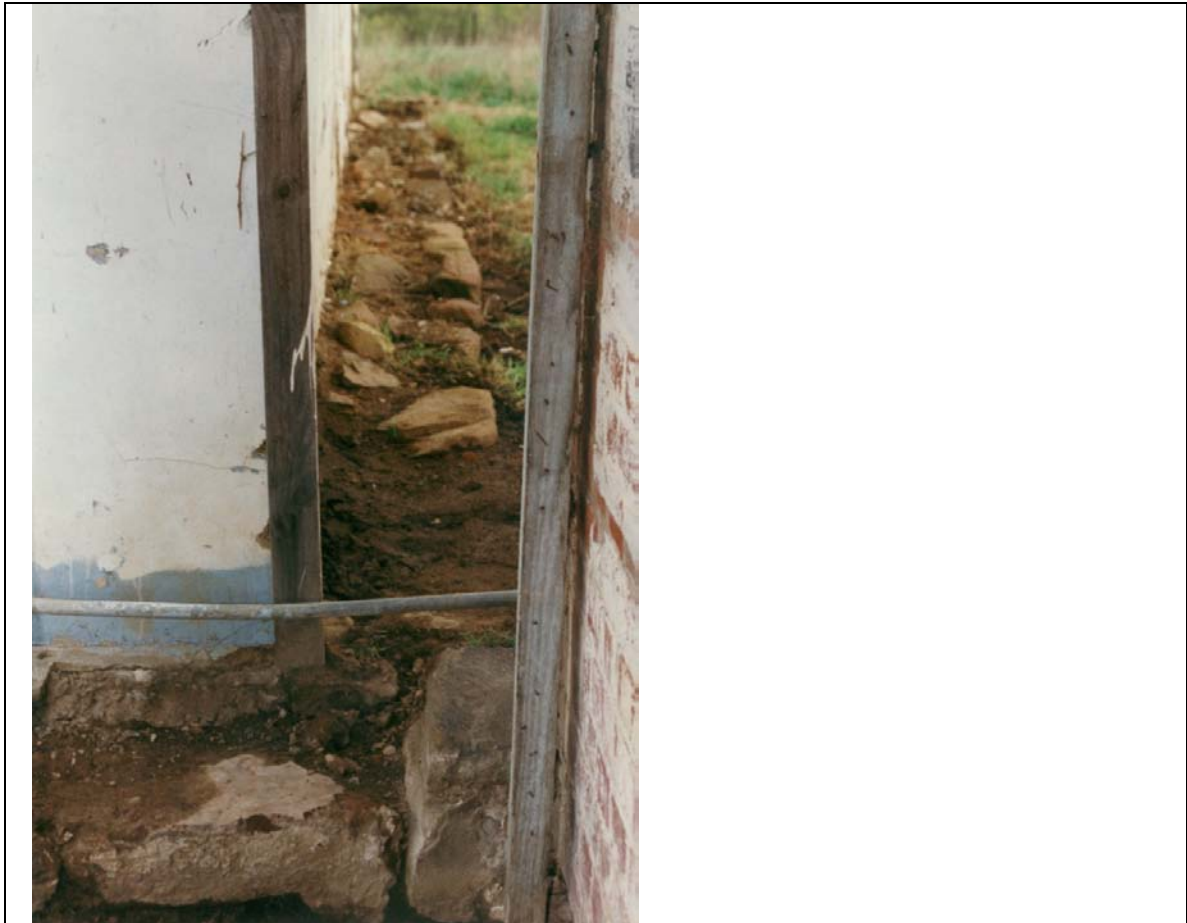
- The chimney stone footing abuts hard with the stone footing of the house, overlapping approximately 4 centimetres. The brickwork over the chimney base is recessed this amount for five courses to allow for clearance for brick installation Photograph 48. This evidence conclusively indicates that the house predates construction of the chimney brickwork and that the house footing most likely is missing its upper course.

Photograph 45 *Seen here is the original sandstone footing at the north wall abandoned in the 1950s renovation to enclose the north end room. This footing abuts the brick chimney base, right, and is visible outside the extant dwarf wall of the east verandah to the left.*

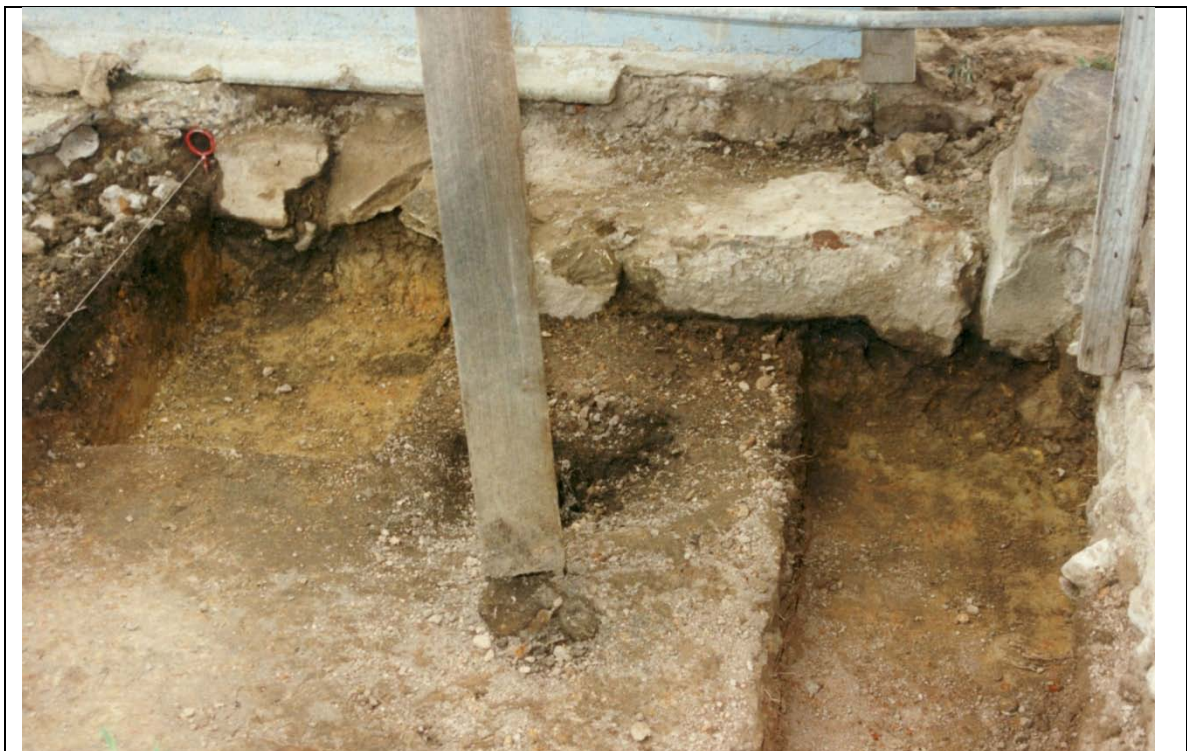
Photograph 46 *These three stones of the homestead footing are covered in mortar and are in situ. Trench 2 at conclusion of excavation.*
