**MAJOR NEWMAN'S PONTVILLE:
FABRIC ANALYSIS AND ARCHAEOLOGICAL
INVESTIGATION OF AN EARLY COLONIAL HOME-
STEAD,
TEMPLESTOWE, VICTORIA
WITH
A COMPARATIVE STUDY OF SWEENEY'S
CULLA HILL, ELTHAM**

A report to Parks Victoria
June 2014

Roger Luebbers PhD
Consultant Archaeologist
August 1997
Revised June 2014

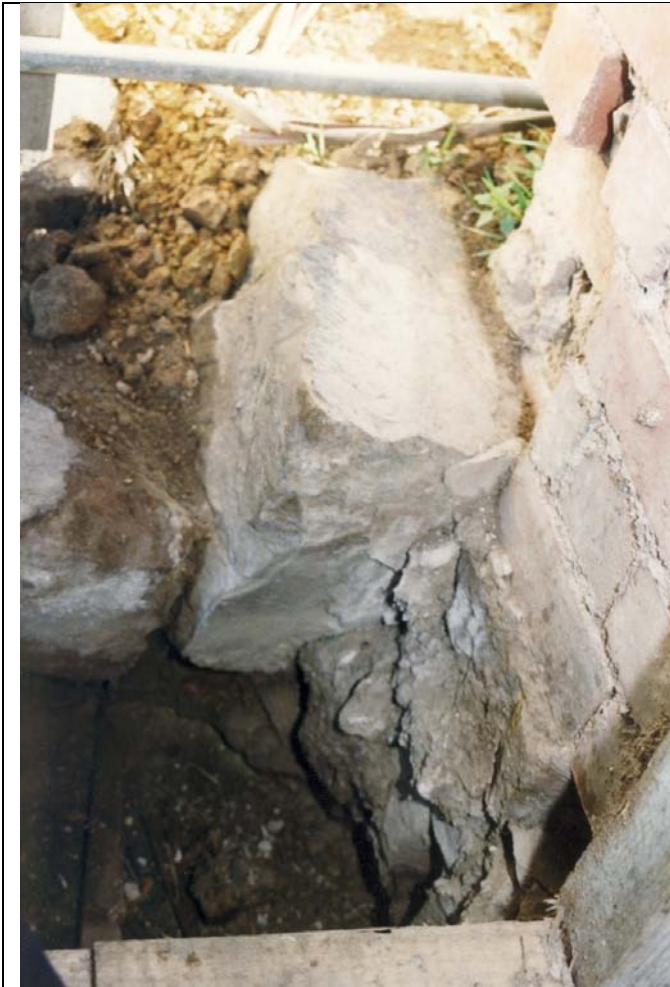
- Three large stones of that footing, constituting the NE corner of the house, are exposed in Trench 2 and are *in situ*, each with a thin layer of render on their vertical faces, Photograph 47. This render also continues across the horizontal upper face of each stone, although the corner stone is considerably higher than the other two and demolition damage has removed some mortar on all three stones. The render clearly continues behind the brick work of the chimney, but it has not been possible to determine whether or not it also continues behind the stone footing of the chimney below the brickwork. If it does continue, then both the render and the chimney footing are younger than the house footing. If it does not, then the chimney footing may have been present when the render was applied and the two footing may be contemporaneous, although their height differences makes this less likely. Regardless of the correct explanation, the chimney brickwork clearly is younger than the house footing against which it abuts. The function of the render on these three stones is unclear.

Photograph 47 *The thin mortar on the upright footing stone seen here continues behind the brickwork of the chimney, right. Trench 2 at conclusion of excavation.*

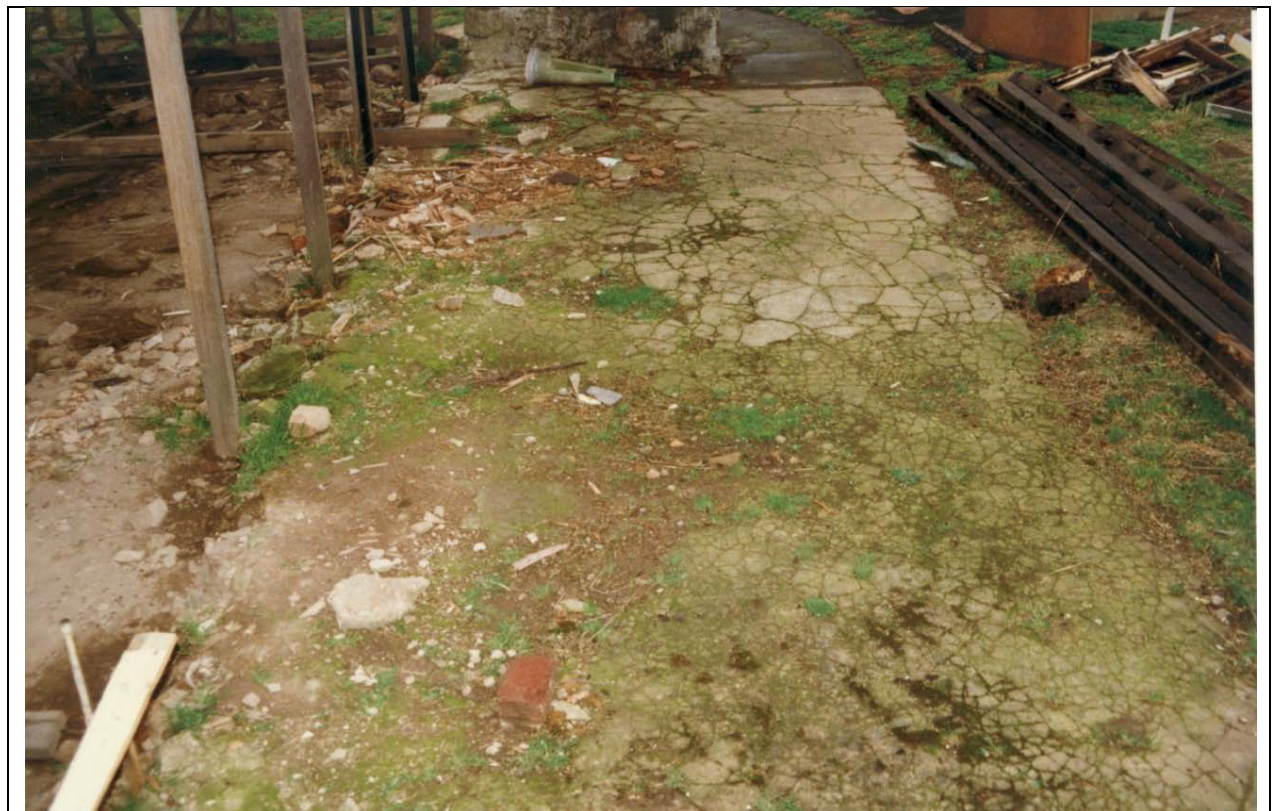
The paving is a 2.2 m wide rectangular thin layer of weak mortar that is highly fragmented throughout its length of ca 5.0 m, Photograph 50. Approximately 30% of it is missing pieces that appear to have migrated to the sub-floor cavity of the kitchen. Mortar of the path once continued into the stand masonry, but subsidence has separated it along the base of the stand.

Photograph 50 *Path on southern face of detached kitchen before Trench 3 was excavated.*

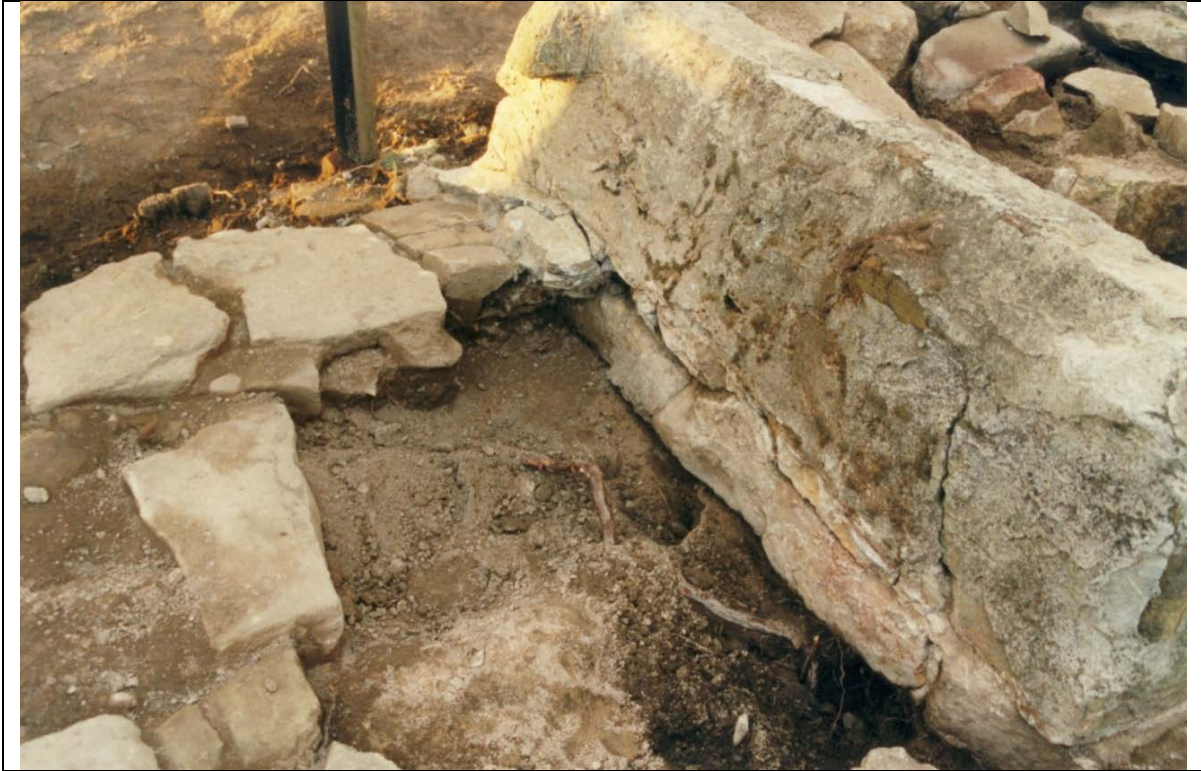
This stand sits on a light rubble footing at ground level and rises to a top edge that is lined by a single level line of red bricks, with a roughly finished render covering all exposed surfaces, Photograph 53. The wall of the stand tapers outward somewhat to its base. The interior of the rectangular structure is filled with loose stone and brick fragments in a matrix of soil. The depth of the interior fill was not determined. The interior render extends across the interior fill, as if to form a thin floor that is now missing in centre of the stand to expose the soil and brick fill. Bricks laid flat form its upper edge and these are flat and level. There is no sub-surface structure to the stand, although in the interest of maintaining fabric stability excavation was not taken substantially inside its perimeter to prove this beyond doubt. The footing on the eastern side of the stand, Photograph 54 is confined to the wall masonry and, like the other base on the opposite side, does not include a sub-surface structure.

The stand is crudely crafted and is somewhat fractured. The two historic photographs covering this area of the precinct, Photographs 1-2 dating to the 1930s clearly indicate that the stand was not present in the undated one when the roof drainage was absent from the kitchen, whereas the Moir photograph shows down pipes draining into a corrugated sheet metal water tank in 1933. Unfortunately the base of the tank is blocked from view so that its support cannot be described. Construction of the stand took place in the first half of the 20th century after the kitchen was built.

Photograph 53 *Seen here is the soil underlying stone blocks of the path at the tank stand, Trench 3.*

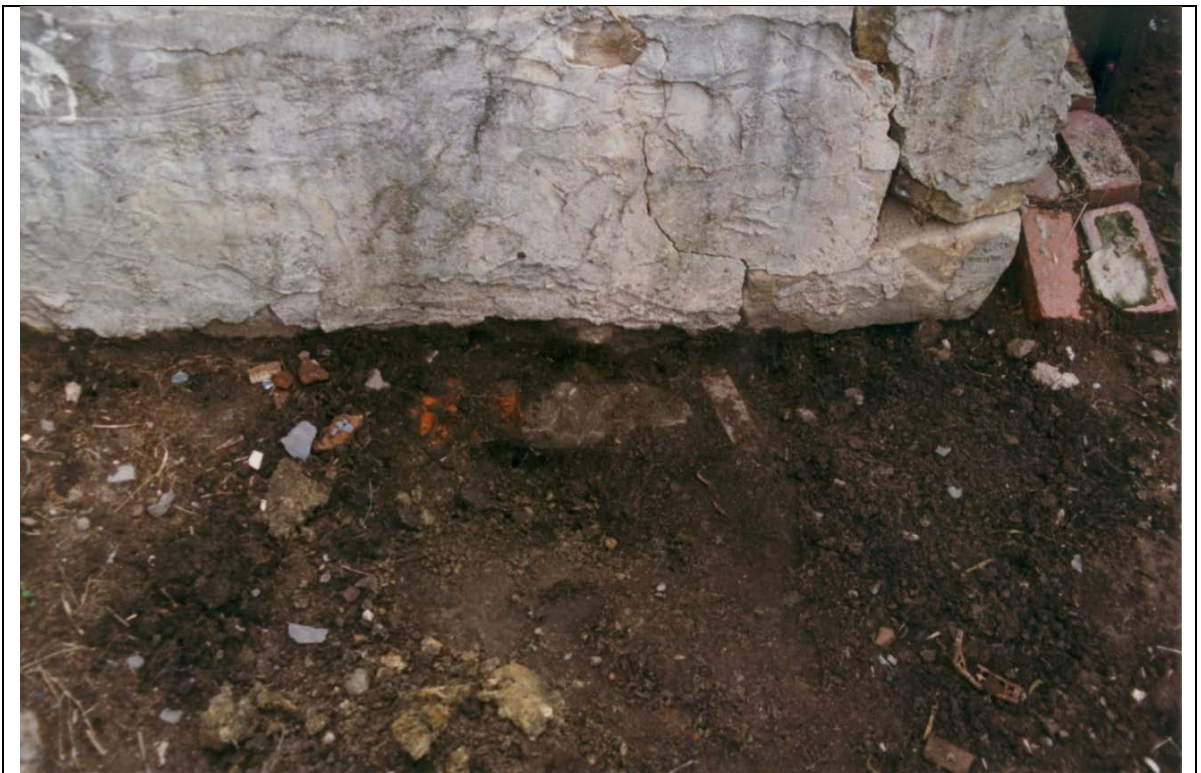
Photograph 54 *Seen here is demolition rubble at the eastern edge of the stone tank stand, Trench 3.*

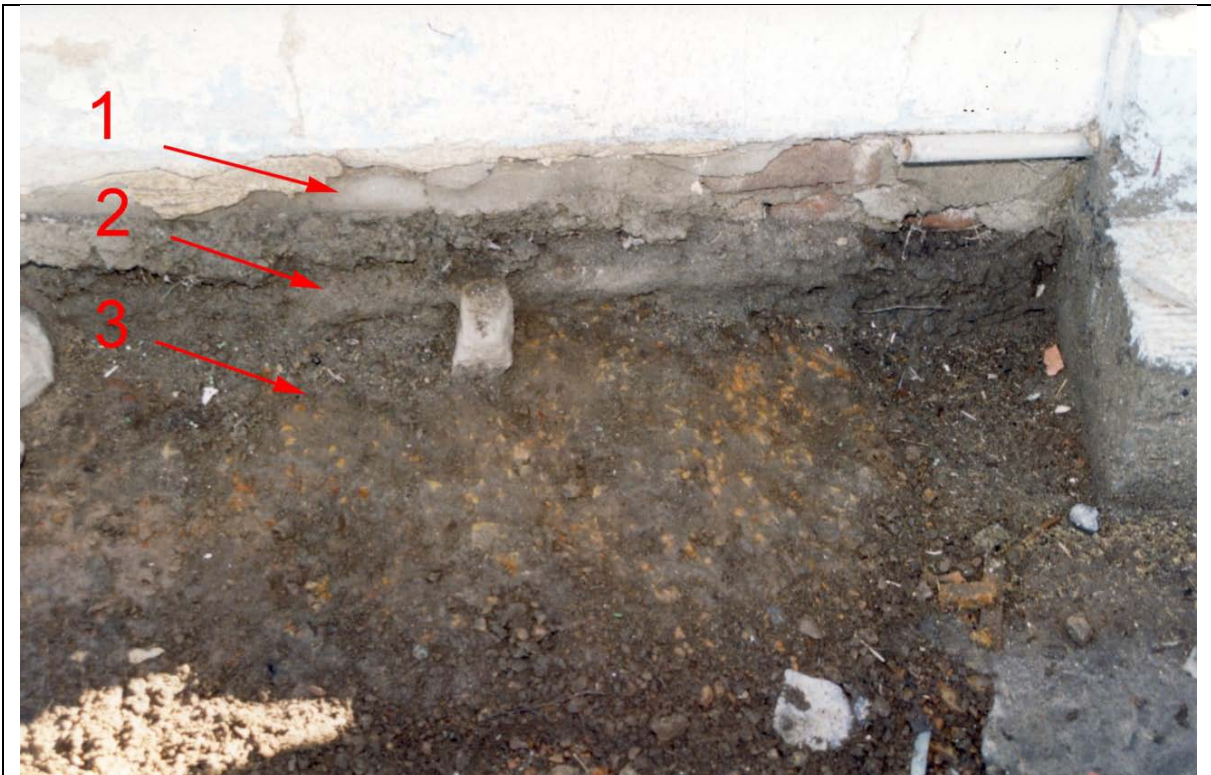
- The house footing was constructed from selected flat fine grain sandstone blocks overlying a rubble base of much smaller stone, which in turn lies on a bright coloured gravel and clay at its base. This clay is a packing, possibly to level and stabilize. Mortar joins some stones of the footing, but much of its top course(s) is missing around the house. A lime-rich exterior render appears to have covered the face of the footing, possibly as a decorative finish and may well have continued up the brick wall of the original house.

Photograph 56 Seen here are 1) brick footing for the dwarf wall, 2) remnant stone footing of the original verandah, and , 3) orange gravel and clay packing beneath the stone, Trench 4.

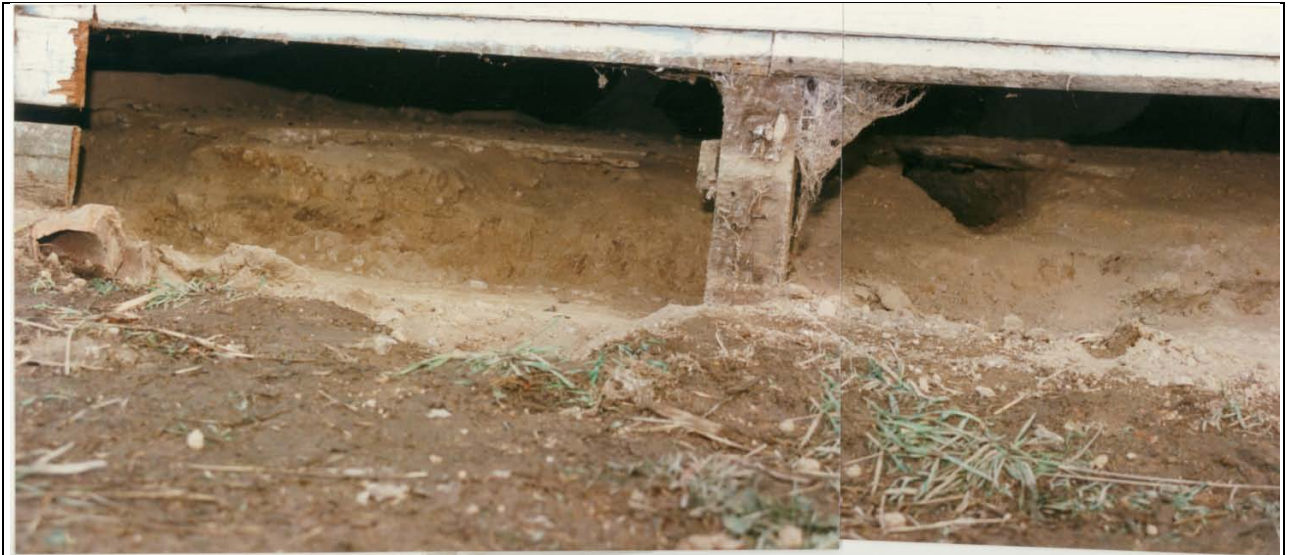
Photograph 57 *Seen here under the raised timber floor of the east verandah is a thin mortar floor capping a layer of fill that may contain artefacts. This floor may be original. A thin concrete footing for the outside wall of the verandah, presumably a renovation that was not used, can be seen abutting the timber upright post. Trench 4. Composite image.*

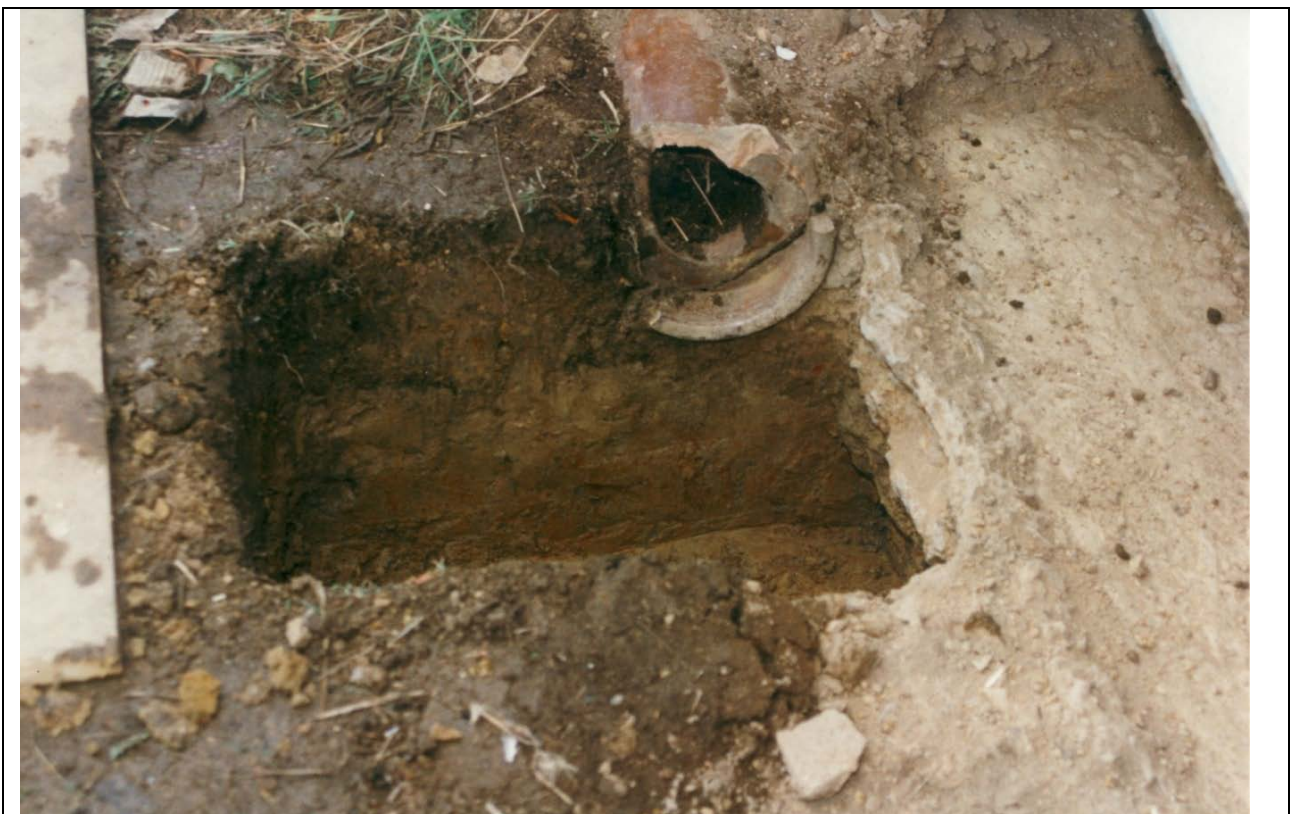
Photograph 58 *Seen here is test pit in Trench 4 revealing a thin concrete footing, right, beneath the outer wall of the east verandah and a shallow trench for a ceramic storm water pipe. The clay beneath the pipe appears to be undisturbed.*

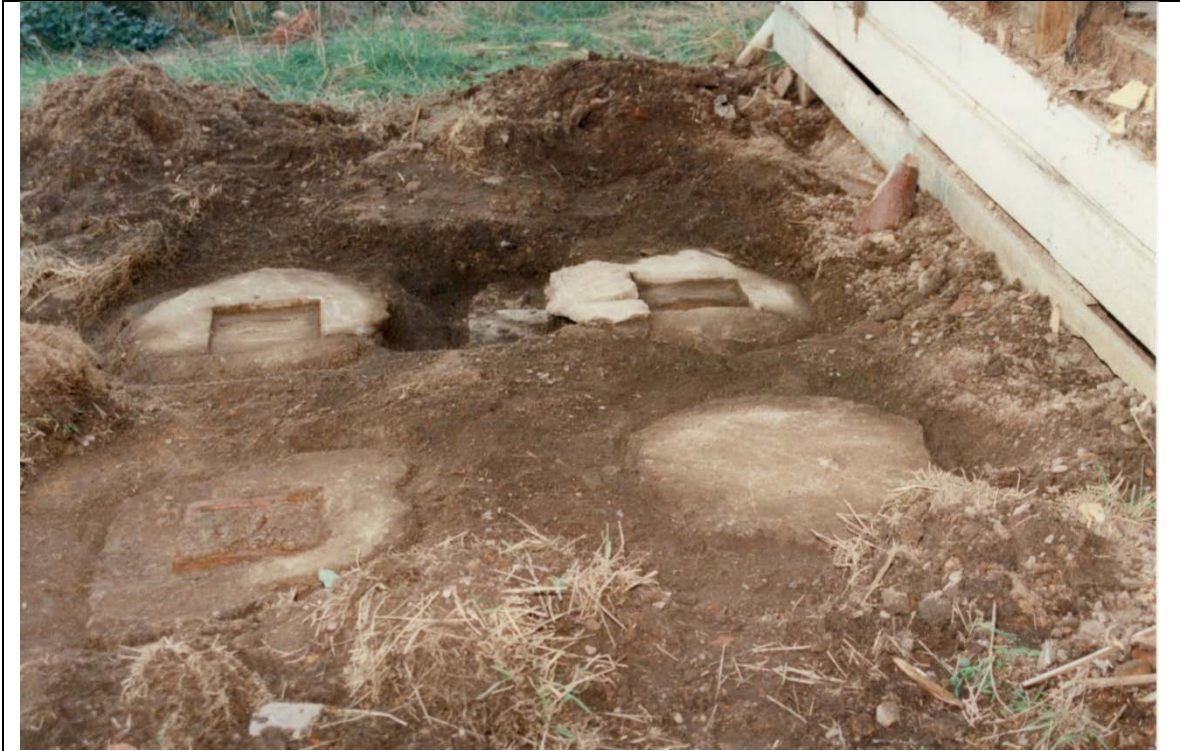
Trench 6 was established to expose four concrete water tank stand footings just below ground surface that were first discovered by soil probe Photograph 62 The footings consist of three courses of brick laid on a concrete base and sealed on top by concrete to support presumably timber legs. As measured from centres, the footings define a square 70 cm on a side. Paired Northcote bricks were present on three of the pads and those in the fourth are mortared over. The surrounding sediment consists of a mixture of charcoal, brick fragments (including those from hand-made bricks), small angular rock, most of which probably is both construction and demolition debris, and accordingly should be considered fill. A 180 mm deep pit was excavated to expose masonry between two pads as shown and this also exposed fill to this depth No attempt was made to further excavate in this trench and no artefacts were retained.

Photograph 62 Trench 6 showing concrete and brick pads of water tank stand.

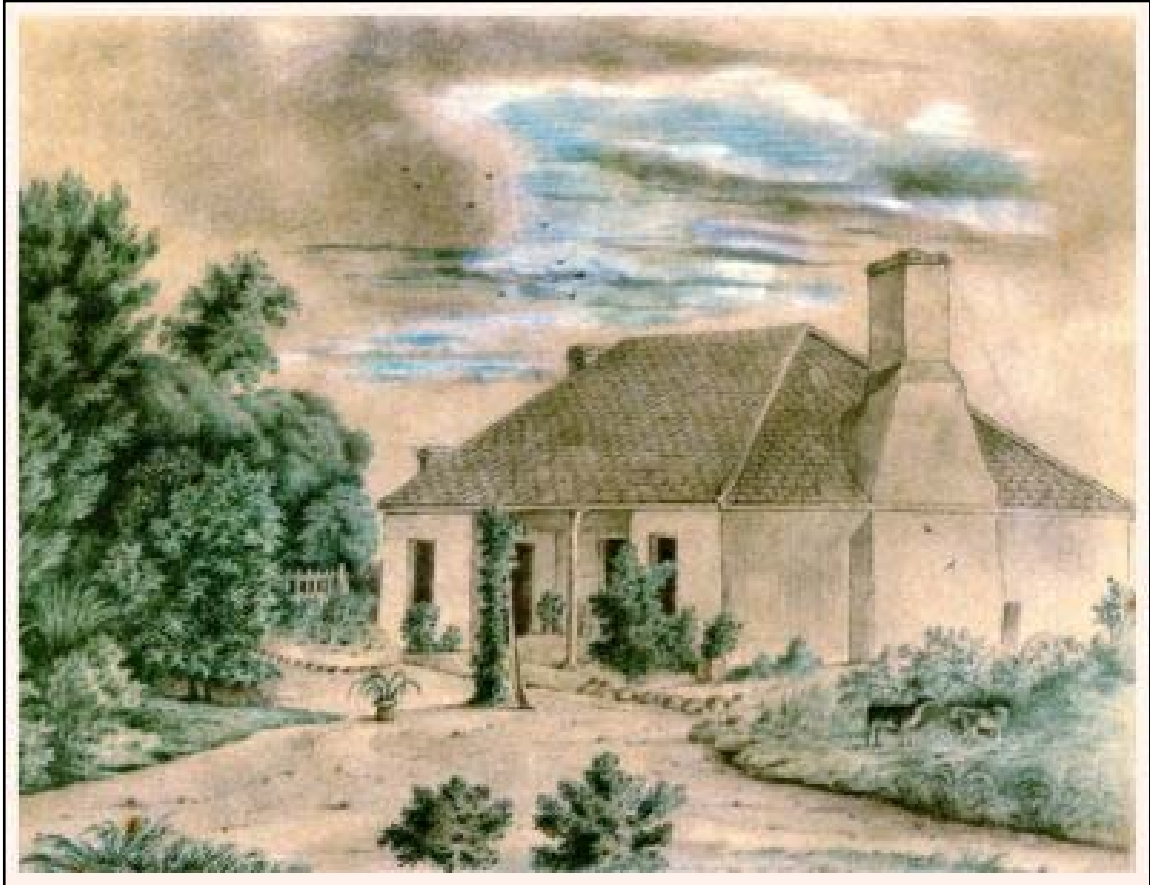
- A drawing of Culla Hill attributed to an itinerate artist Charles Bertie who compiled it in c. 1892 at the request of Mary Sweeney, Photograph 65. It depicts the homestead as viewed from the north-east garden, showing the front verandah and the large external fireplace in the north of the building. It has a slate roof.

Photograph 65 Charles H. Bertie drawing of Culla Hill compiled in ca. 1892. Courtesy Peter Cuffley.

The only historical documentation revealing the fireplace design obtained for this study is contained in Photographs 65 & 66. These images clearly show a massive stone and brick fireplace with deep penetration of the roof-line, pictures that are well supported by the fabric analysis presented here. But it raises the question of why such a large fireplace was installed in such a small floor space:- compared to the south chimney in the house and the chimneys in the other buildings at Culla Hill, this one is by far the largest and yet it opened into a moderately small room. The best explanation for this is that the chimney had more than one flue and therefore heated more than one room. The most likely functional possibilities of this design are that it was a kitchen fireplace in its own right, in which case it may have had both an oven and a cooking fire, or that it heated one or both adjoining side rooms with separate fireboxes:- corner fireplaces are possibilities. It is plausible too that a small fireplace heated the loft. It is therefore feasible that the fireplace contained up to three flues in order to heat three separate rooms;- the central room, the tiny corner room at the end of the front verandah, and the rear corner room, which may have been a kitchen. If this were the case, only one of the six rooms in the house was unheated at the time of construction and the apparent over-size scale of the fireplace is a generous adaptation for heating a 1850s rural residence.

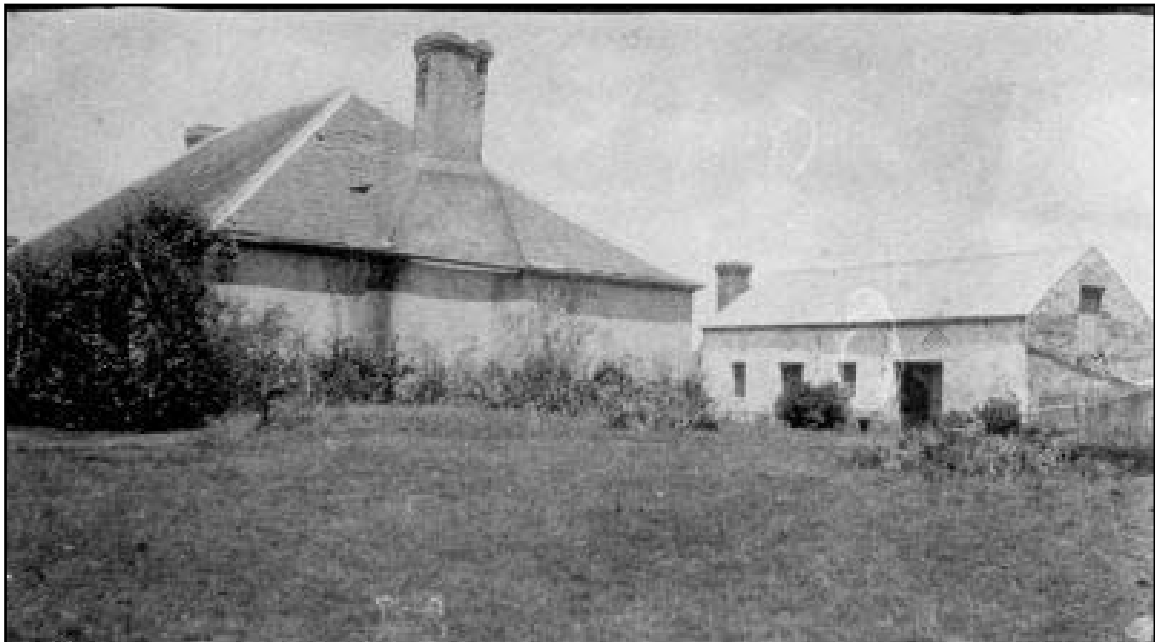
- An undated photograph of the homestead and barn, Photograph 66, believed to predate the 1940s Home Beautiful article. The north fireplace is prominent in this image.

Photograph 66 Shown here is the northern end of Culla Hill homestead with the main fireplace intact and the barn seen to rear. <http://vrwc.org.au/carrucan-pics/displayimage.php?album=5&pos=24>

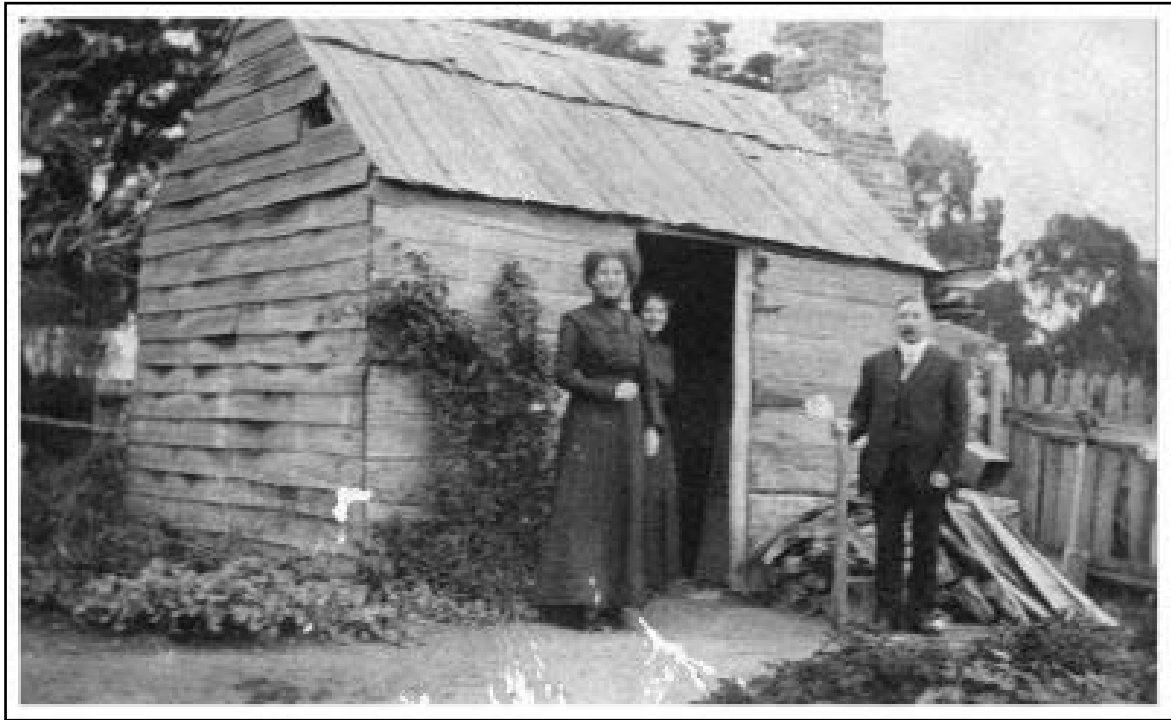
- An image of the weatherboard hut created in early 19th century is said to be first hut Sweeney built on the property, Photography 67. This hut was sited some ten metres away from the cottage and may well have been a kitchen for most of its life in the 19th century.

Photograph 67 The weather board shed seen here is reported to be an original Sweeney dwelling at Culla Hill.

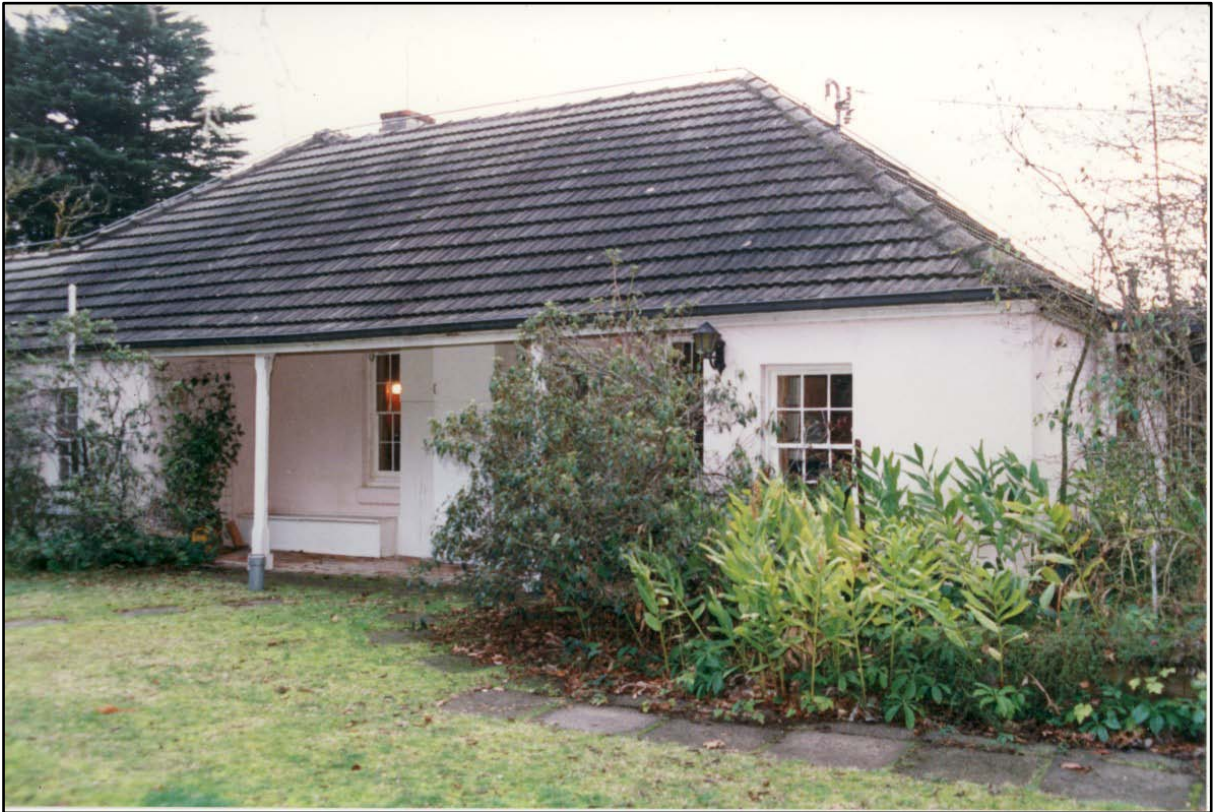
The most extensive renovations to Culla Hill took place after the Burston family purchased the property in 1950 and set about changes to suit the needs of a young family. A blue print compiled by the Melbourne architectural firm Marcus Martin in December 1950 indicates that two bedrooms and a bath had been added to the southern end of the homestead prior to the first stage of expansion. Their plans included the addition of two more bedrooms further south of the previous renovation, with the end room being refitted with a new hearth that was relocated slightly from an old position. At this stage, the south fireplace had been relocated a few feet west and the southern end of the original Culla Hill homestead had already been re-built by the previous tenants. A subsequent stage of additions included the construction of a large family/sitting room, *en suite* bathroom and master bedroom to the west, and extensions that created a wing that included a kitchenette, dark room, and a generous family room. It was at this point that the original front entry to the older homestead section was abandoned in favour of a centralised entrance porch and passageway which lead into a main reception area. A view of the front of Culla Hill reveals little has changed, Photograph 68

Photograph 68 Front exterior, Culla Hill 1997, being presented for auction in June.

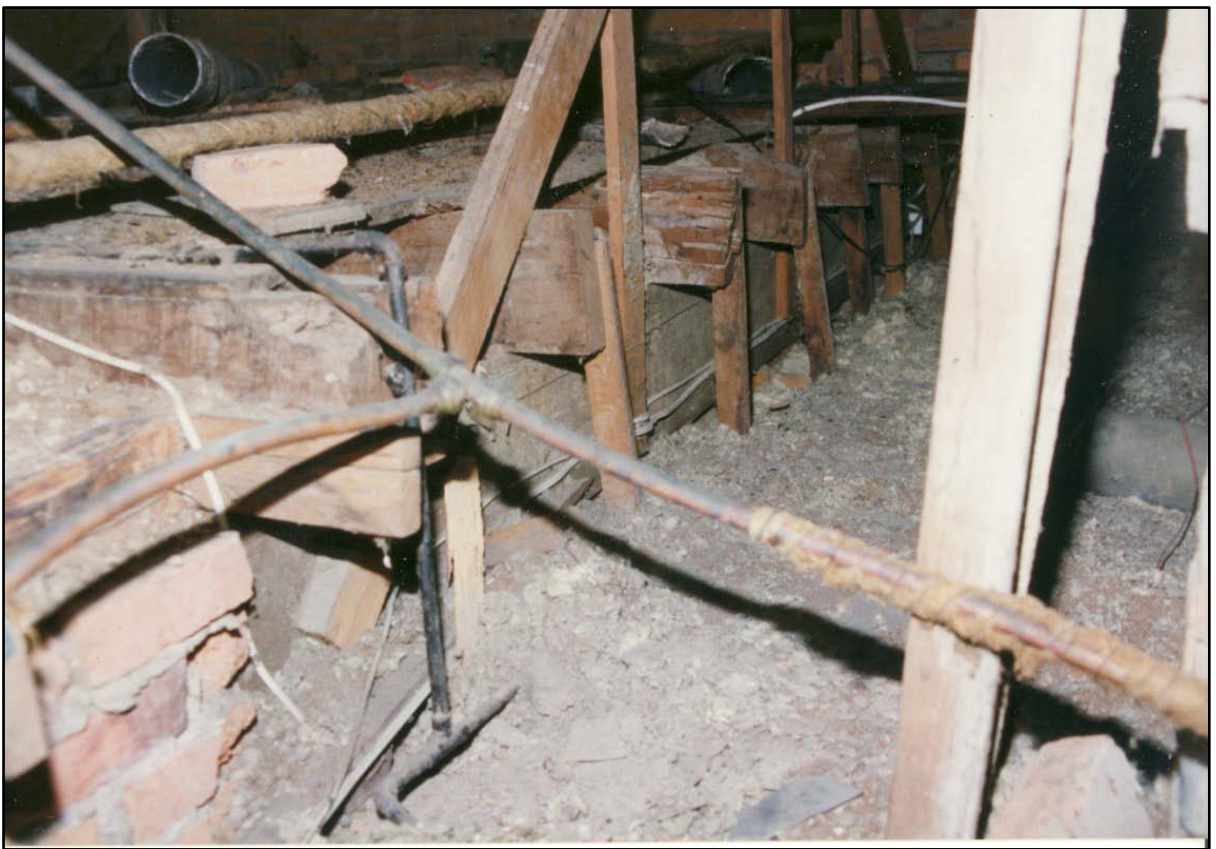
Photograph 69 Shown here are renovated ceiling joists in loft area, Culla Hill, with ceiling joists

A floor with similar boards covers the entire ceiling over the former nursery in what might be termed a side loft. They are attached to short hard-wood joists with 2 inch Ewbank nails, but insulation obscures the exact arrangement of the floor design. Details of the 1951 renovation that included the installation of a new timber beam to support the joists in the central room and the side loft can be seen in Photograph 69.

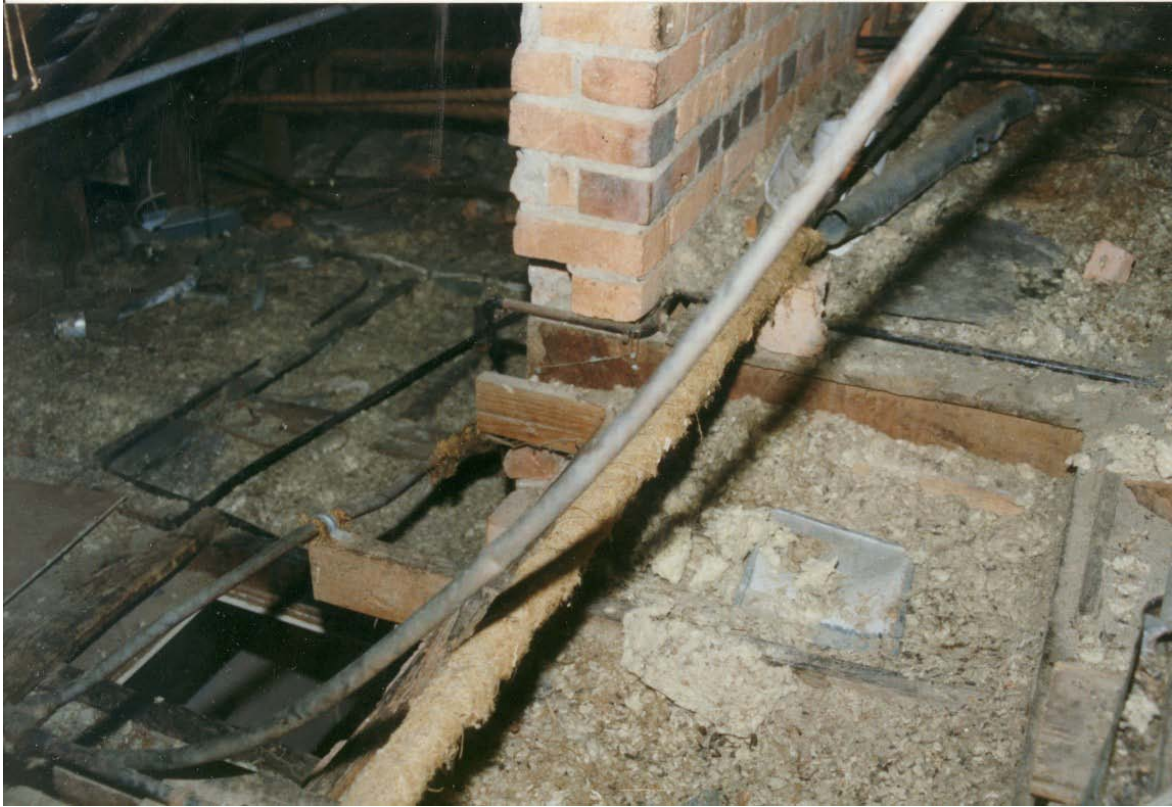
Photograph 70 *Entrance way through ceiling to loft. entrance to side loft , lower left. The brick loft wall is seen centre and central loft is to the right.*

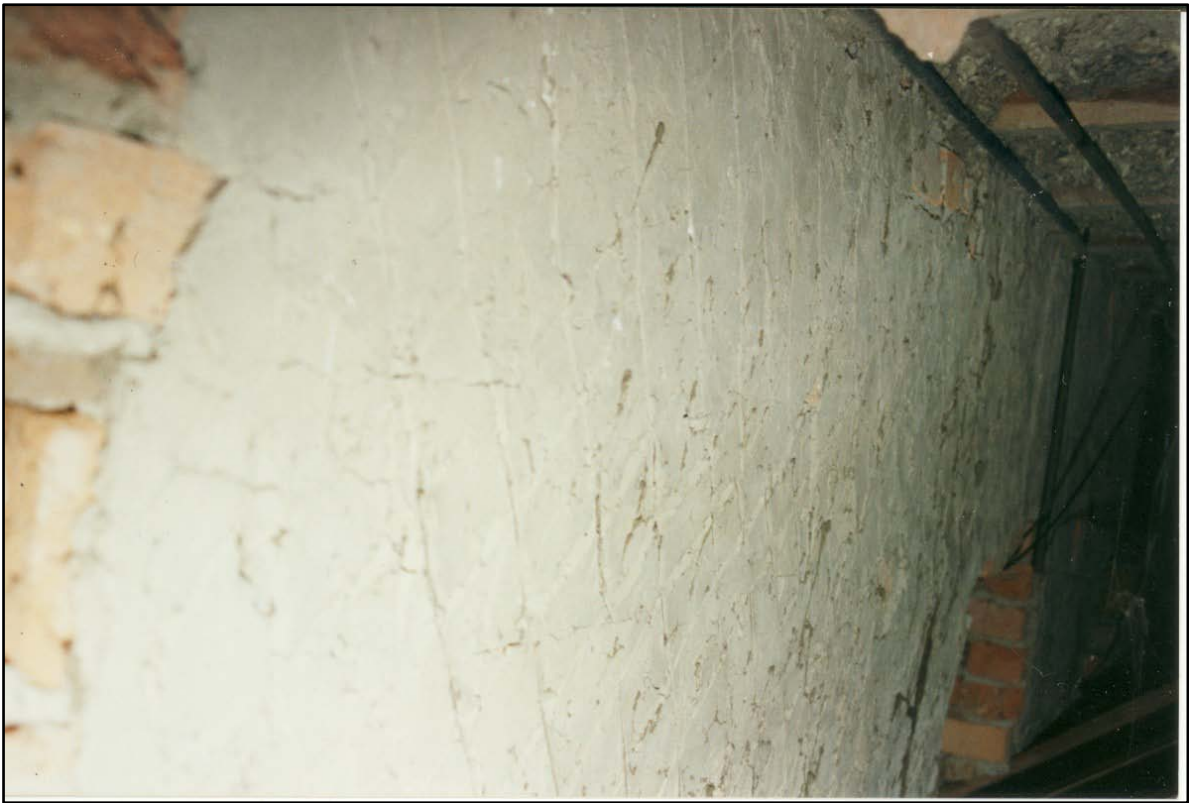
Photograph 71 *The plaster on this vertical wall above the front verandah ceiling has been scored for a finishing coat.*

A lath and plaster ceiling is also attached to joists over the front verandah. The external vertical face of the core wall above the ceiling, Photograph 71, has been rendered in a fine textured semi-hard lime-rich mortar, possibly a mixture of Roman Cement and sandy lime. A set of criss-crossing parallel lines have been cut across the render for the height of the wall and full width of the verandah, the pattern continuing behind the ceiling joinery where it is obscured by the lath and plaster. The render was plastic at the time the lines were created and the tool used cut deep incisions like those of a trowel. The affect is a diamond pattern across the whole upper wall of the verandah. While the lines are generally straight and regularly spaced, they are clearly not ruled. A thin "crust" of fines has been created on the render surface (as viewed microscopically in cross-section) indicating that the mixture was tooled at the time of application, possibly with a wooden float. It is usual for a scratch coat or the initial floated coat to be scored in this manner to promote adhesion of subsequent plaster, and for it to be spread with a float in an attempt to achieve a uniform smooth surface. Whether or not the diamond pattern was itself intended to be ornamental is not certain:- the application of a render to the upper wall indicates the intention to create a weather seal and possibly to finish off with a decorative plaster for viewing from below. Installation of the lath and plaster ceiling over the verandah hid this upper wall from view and hence ended its decorative function, probably either at the end of construction or sometime soon after.

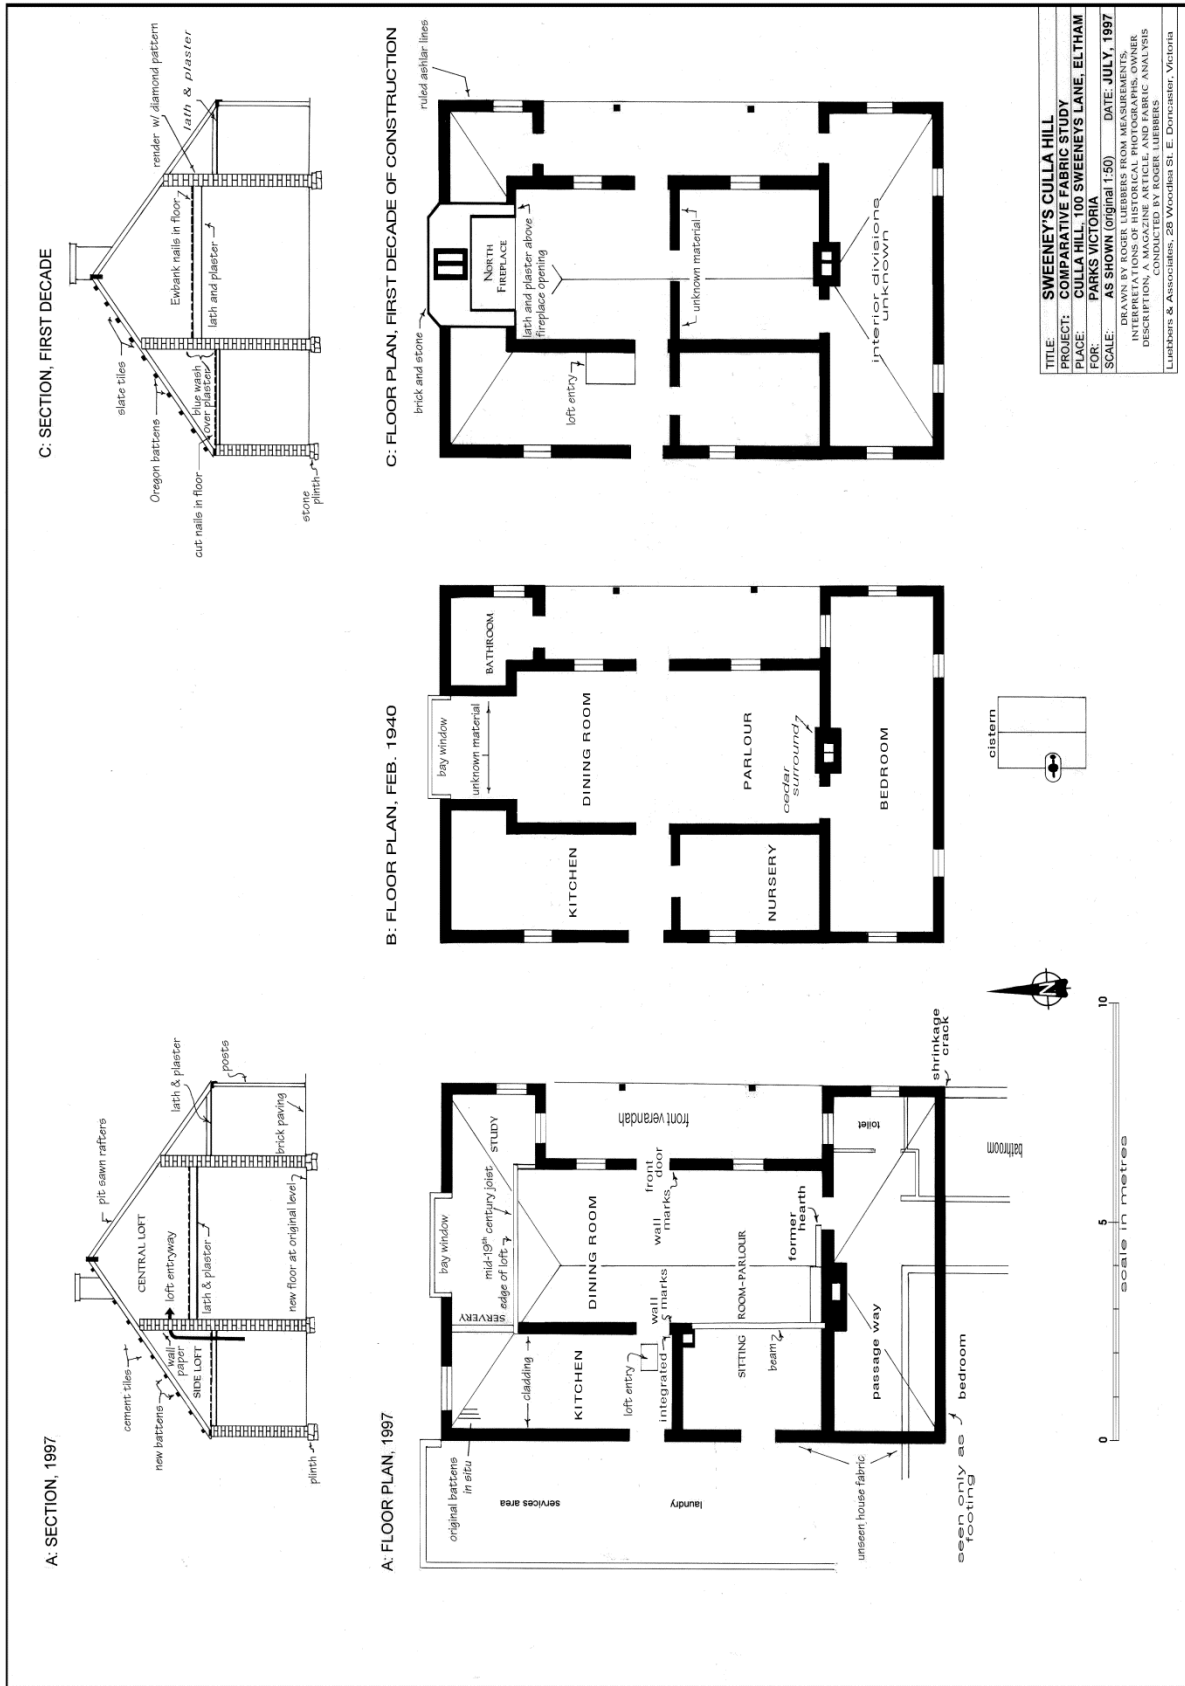
FIGURE 10 Floor plan of Culla Hill at three periods of habitation.

Analysis of images published in 1940 allow a description of house layout prior to the Burston renovations in the early 1950s, Figure 9B. The core living area was open and not divided by a central wall and a fireplace appears in the near mid-point of its southern wall heating it and a long end room through a double flue. The northern fireplace had been replaced by floor-to-ceiling French doors and a small nursery was retained from the original layout. Otherwise, the layout from the original construction remained unaltered, Figure 9C.

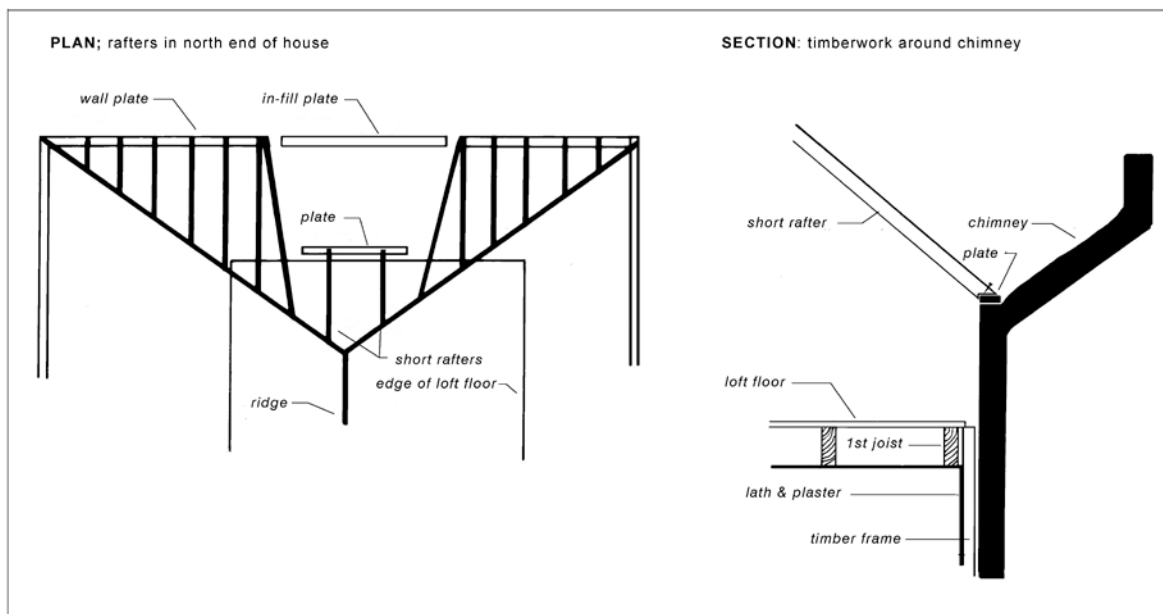
Figure 11 Plan of timber elements in Culla Hill roof and section junction between the central loft and oversize fireplace in northern end of house. R. Luebbers.

The original rafters all survive *in situ* in the end of the building, although new ones have been added to fill the hole left in the roof when the fireplace was removed prior to 1938. The arrangement of both rafters and wall plates in this end of the house is illustrated in Figure 11. The long ones to the sides were angled to avoid the fireplace and continue as single pieces to wall plates, thus giving no direct indication of the size of the demolished masonry structure. The length of the in-fill wall plate is slightly greater than the outside width of the extant bay window, thereby suggesting a maximum chimney width of ca. 2.6 metres. The ends of the two central short rafters however are notched and contain *in situ* machine-made, Type 1 nails (Ewbank), for installation on a wall plate, although the plate itself is missing.

These overshoot slightly the position of the first ceiling joist so that they could not have been supported by any structure associated with the loft. The only structure which could have supported these rafters is a wall plate on the front breast of the fireplace itself. At this position, the penetration of the fireplace into the room at loft level was a full **FIVE** feet as measured horizontally from the inside edge of the external wall. This evidence strongly implies that the fireplace was designed to be a large walk-in style structure and is so drawn in the floor plan, with its internal surround most probably consisting of a timber frame covered in lath and plaster. The shape of the fireplace is however conjecture and must remain so until the sub-floor fabric can be assessed archaeologically or definitive historical documentation becomes available.

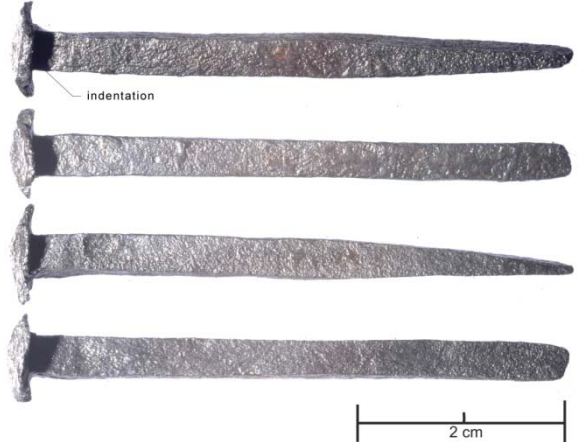
| <p>N1.19</p> | <p>2" iron nail (1), square shank, w/o flare at head, no burring. Thin cusped rose head. Shank taper opposing faces. Rectangular indentation 3.5 mm long on one face at head extends across shank width, slight indentation opposing surface, the deeper mark rotated away from shank axis. Rotation of 1-2° of shank around its axis is noted. Found <i>in situ</i> in re-used rafter in batten position. A</p> | <p>Head dia. = 8.4 X 8.7 mm Shank = 3.8 x 4.1 mm Length=53.5</p> | <p>Construction nail, cut profiled N1.19, Pontville</p> |

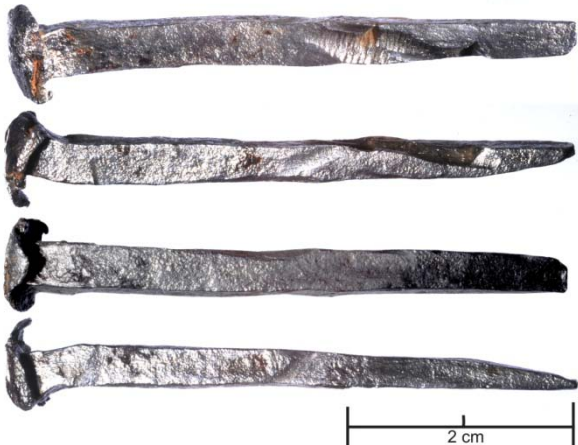
| <p>N1.20</p> | <p>2" wrought iron square neck cut nail (1), square shank, w/o flare at head, burring on sides. Indentation 4.5 mm long on one face at neck extends across shank width, slight indentation opposite face. Slight Axial rotation. Thin cusped head, roughly round, offset. Tapered from head to point on four faces. Point spade shaped. Found loose in ceiling surface in loft, north room. Irregularity in surface treatment and thickness variation observed, slight tip and extraction damage. A</p> | <p>Head dia. = 9.4-10.6 mm Shank = 4.1- 4.3 mm Length=52.6</p> | <p>Construction nail, N1.20, Pontville</p> |

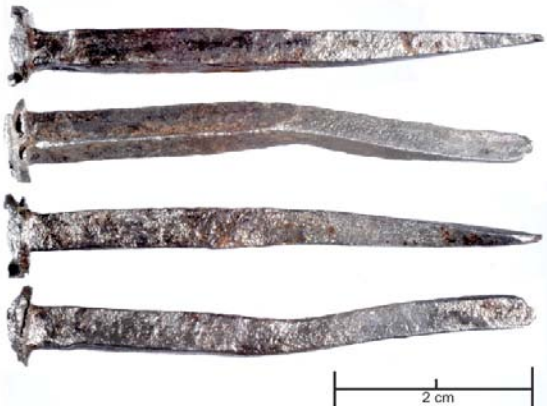
| <p>N1.21</p> | <p>2" iron square neck cut nail (1), Low roughly round thin head w/o flare at neck, burrs on sides of opposing taper. Indentation 4.5 mm long on one face at neck, slight on other. Thin flat head, roughly round. Tapered from mid-shank to point on opposing faces, lesser taper on other opposing faces. Point spade shaped. Irregularity in surface treatment and thickness variation suggest nail is hand-made. Found <i>in situ</i> on pit sawn rafter in extant roof in position of batten. A</p> | <p>Head dia. = 9.5 m damaged Shank = 4.1 x 4.3 mm Length=55.1 mm</p> | <p>Construction iron nail; Nail N1.21; Pontville</p> |

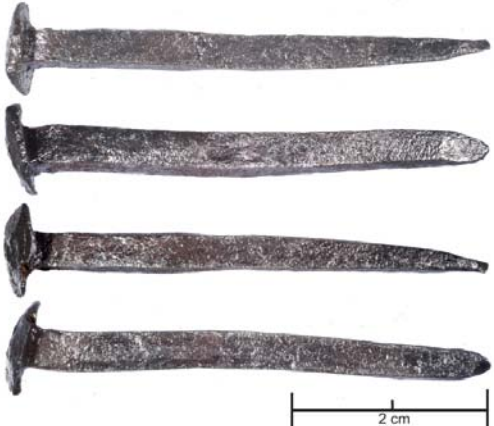
| <p>N1.22</p> | <p>2" wrought iron square neck cut nail (1), square shank, w/o flare at head, no burring. Indentation 3.5 mm long on one face at head. Thin flat head, roughly round. Tapered from mid-shank to point all four faces. Pointed tip.. Found loose on ceiling above north room in loft. E</p> | <p>Head dia. = 9.5 x 9.8 mm Shank = 3.9 x 4.0 mm Length= 49.6 mm</p> | <p>Construction Nail, N1.22, Pontville</p> |

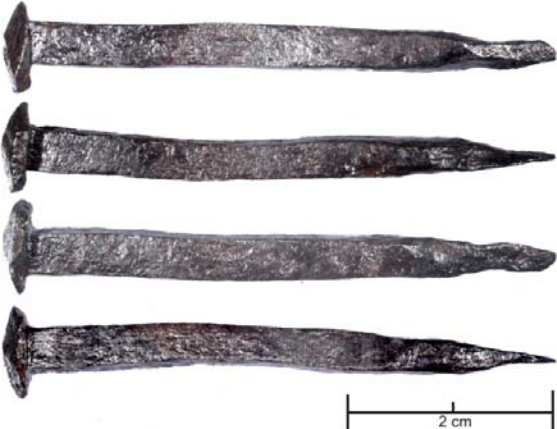
| <p>N1.23</p> | <p>2" wrought iron square neck cut nail (1). w/o flare at head, slight burring on one side. Slight indentation 3.5 mm long on one face at neck. Thin flat head, roughly round. Tapered from mid-shank on <u>all</u> faces. Tip is sharply pointed. Irregularity in surface treatment and thickness variation suggest nail is handmade. Found loose in wall cavity in loft. E</p> | <p>Head dia. = 8.6 x 8.8 mm Shank = 4.0 x 4.0 mm Length= 52.6 mm</p> | <p>Construction Nail, N1.23, Pontville</p> |
