**MAJOR NEWMAN'S PONTVILLE:
FABRIC ANALYSIS AND ARCHAEOLOGICAL
INVESTIGATION OF AN EARLY COLONIAL HOME-
STEAD,
TEMPLESTOWE, VICTORIA
WITH
A COMPARATIVE STUDY OF SWEENEY'S
CULLA HILL, ELTHAM**

A report to Parks Victoria
June 2014

Roger Luebbers PhD
Consultant Archaeologist
August 1997
Revised June 2014

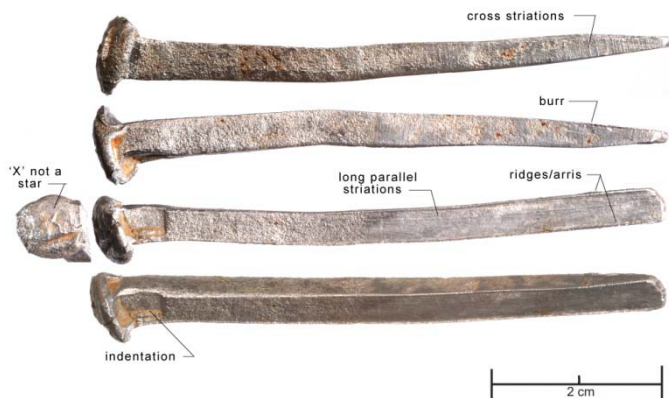
| <p>N1.24</p> | <p>3" wrought iron square neck cut nail (1). Square shank joining head w/o flare; deep single offset depression one face at neck from vice. Tapered from mid-shank, w/ pair of deep ridges one face, none on opposite. A burr is present on adjacent side suggesting this is a cut nail. Spade point. A mark of a raised cross or "X" is centred on the head; although heavily weathered, this mark does not appear to be a star. Taken <i>in situ</i> from pit sawn ceiling joist trimming piece, south room. A</p> | <p>Head dia. = 8.2 x 9.7 mm Shank = 4.4 x 4.7 mm Length= 68.5 mm</p> | <p>Construction nail; cut & pressed, N1.24: Pontville</p> |

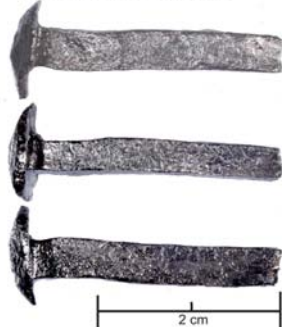
| <p>N1.26</p> | <p>Wrought iron nail, (1) incomplete, with square shank and roughly triangular thin, head w/ indistinct facets. Distinct major and opposing minor indentation at neck. Found <i>in situ</i> in position on batten on reused pit sawn rafter in homestead loft. E</p> | <p>Head dia. = 10.0 x 10.6 mm Shank = 3.5 x 4.0 mm Length= 27.0 mm incomplete</p> | <p>Construction Nail, N1.26, Pontville</p> |

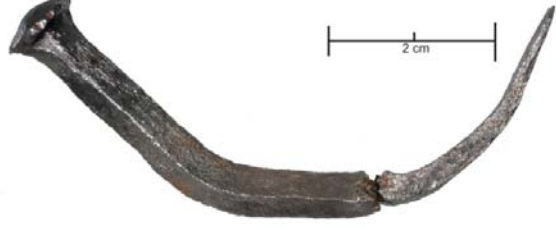
| <p>N1.27</p> | <p>3 " Ewbank iron nail, (1) in two pieces, with square shank and roughly square thin, head, flared on opposing sides. Slight burring one side near tip, tapering from mid-shank to spade point. Found <i>in situ</i> in position on batten on reused pit sawn rafter.</p> | <p>Head dia. = 8.4 x 8.8 mm Shank = 4.5 x 4.5 mm Length= 77.0 mm estimated</p> | <p>Ewbank nail, N1.27, batten to rafter, Pontville homestead</p> |

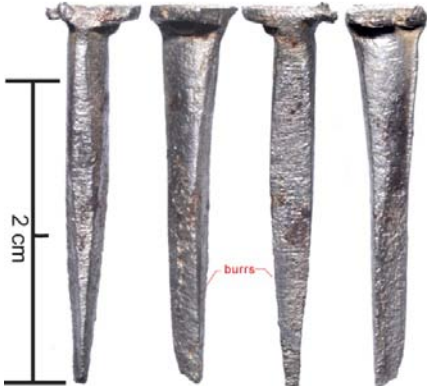
| <p>N1.28</p> | <p>Wrought iron cut lath tack (1). Roughly triangular shank, flared neck at head, finished with sharp point and sharp cornered triangular cross section w/ burrs on two faces from shearing blade; Collected loose from sub-floor cavity, central room, probably unused. A</p> | <p>Head dia. = 5.7 x 6.8 mm Shank = 3.0 x 4.3 mm Length= 26.8 mm</p> | <p>Lathing tack, Nail N1.28, Pontville</p> |

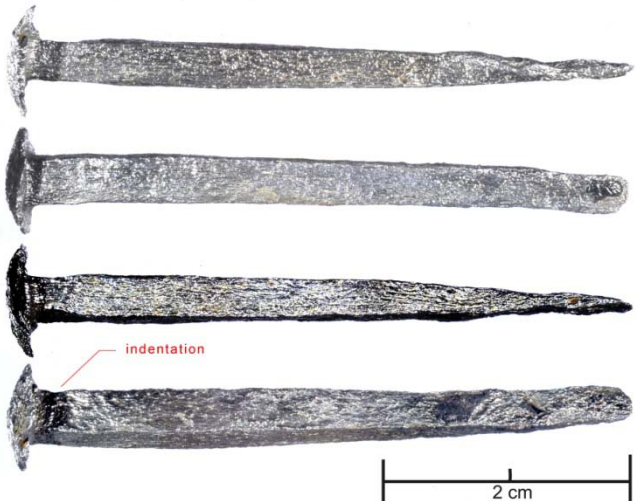
| <p>N1.31</p> | <p>Iron square neck cut nail (1), 2". Square shank and neck meets head abruptly w/o flare; one major and opposing minor indentation at neck, slight cusped shank sides with burrs. Shank tapers broadly along two faces from mid-shaft, more sharply two other faces 3/4 shaft. Tip distortion noted but probably was square pointed. Probably cut from profiled stock. Roughly round head, thin and slightly cusped. A</p> | <p>Head dia. = 8.5 x 9.2 mm Shank dia. = 3.6 x 3.8 mm Length = 51.5 mm</p> | <p>Iron wrought nail, N1.31, Pontville roof</p> |

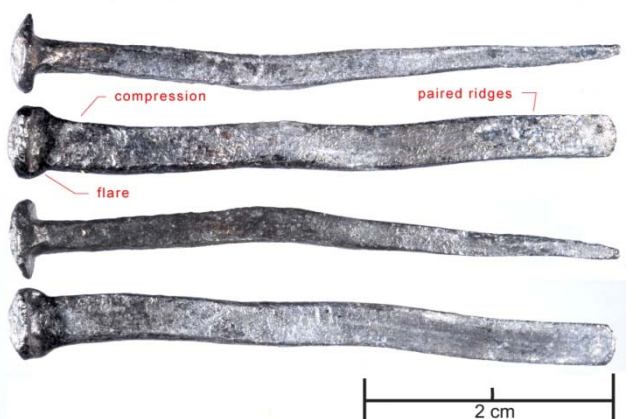
| <p>N1.32</p> | <p>Ewbank iron nail (1). Rectangular shank, flared at head; tapered opposing faces, compression marks at neck w/ rounded shank edges but shank edges are sharp same distance as taper. Ridges on shank only near tip, one face. Spade shaped tip w/shear trim marks. A</p> | <p>Head dia. = 5.8 x 6.5 mm Shank dia. = 2.5 x 3.9 mm Length = 48.9 mm</p> | <p>Ewbank nail, N1.32, Pontville roof</p> |

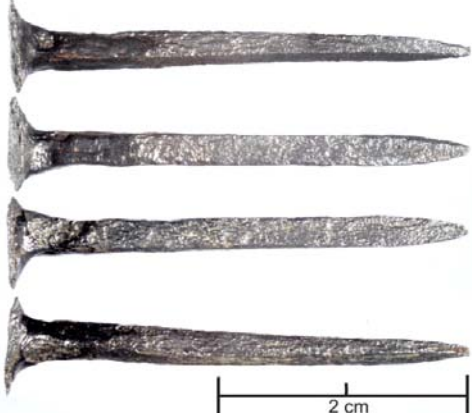
| <p>N1.33</p> | <p>Iron clout (1). Nearly round thin flat off-set head w/ neck terminating w/ wide flare at head w/o indentation or compression. Shank w/ low opposing taper from mid-point and other faces w/ high taper at tip. A</p> | <p>Head dia. = 7.0 x 8.0 mm Shank dia. = 2.6 x 2.3 mm Length = 37.1</p> | <p>Hand wrought nail, N1.33, Pontville</p> |

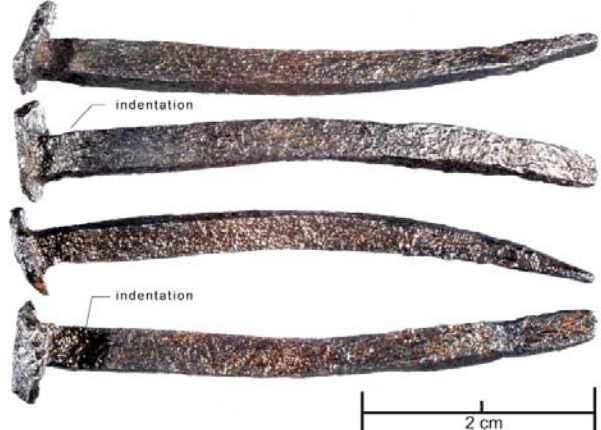
| <p>1.34</p> | <p>Iron square neck wrought iron cut nail (1), 2". Thin irregular offset flat head, square shank and neck meets head w/o flare and tapered . Opposing indentations hard against head. Single burr on diagonal corners indicates this is a cut nail, possibly from a profiled sheet. Irregular shape near tip may be from hammering during installation but a rotational twist around axis is noted. Retrieved loose in loft recesses. A</p> | <p>Head dia. = 8.5 x 9.5mm Shank dia. = 3.7 x 3.9 mm Length = 52.0</p> | <p>Construction nail; N1.34: Pontville</p> |

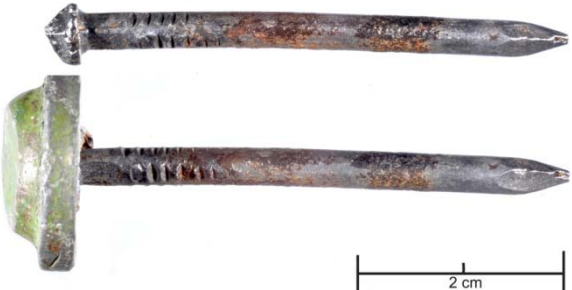
| No. | Description-Wire nails | Measurements | Image |
|---|--|--|--|
| N2.1 | 2" Wire roofing nail (1), with round domed lead washer on head. Base of lead head is flat (un-cupped). Roughened crimp marks near head, square neck at head, four facet point and groove runs full length of shank, shank flared at neck. High rose head. Taken from sediments in sub-floor area of kitchen. Steep 4 sided facetted head. Painted green. Significance: held first corrugated iron sheets to roof (Gospel Oaks brand). Shown here is image of assembled lead head and nail, and second of same nail w/o head. Square neck suggests it is an iron nail. A. | Head dia. = 20.0 mm Shank dia. = 3.8 mm Length = 54.5 mm | <p data-bbox="1444 320 1823 336">Roofing Nail, N2.1a, Pontville detached kitchen</p> |

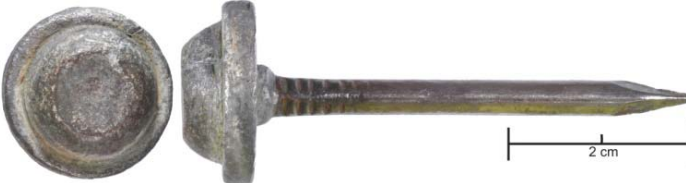
| No. | Description-Wire nails | Measurements | Image |
|---|--|--|--|
| 2.1b | 2" Wire roofing nail (1), with round domed lead washer on head. Base of lead head is flat (un-cupped) w/ lead protrusion around neck. Roughened crimp marks near head, square shank at head, four facet point and a groove runs full length of shank, shank flared at head. Taken <i>in situ</i> from extant rafter of kitchen. Painted green. Significance: held first corrugated iron sheets to roof (Gospel Oaks brand). Shown here is image of assembled lead head and nail, and head from top view. A | Head dia. = 19.8 mm Shank dia. = 3.8 mm Length = 54.5 mm | <p data-bbox="1420 659 1834 675">Wire nail roofing clout, N2.1b, Pontville kitchen</p> |

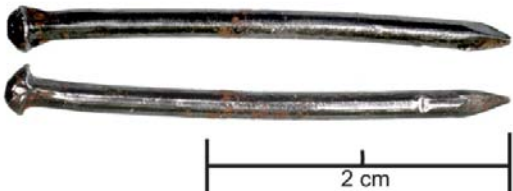
| <p>N2.3b</p> | <p>1¼" wire brads (1) with distinct well formed offset rose-head, two opposing major haunches , 4 sided point. Taken <i>in situ</i> from extant Baltic pine ceiling lining in central room of house. Exact contemporary of timber ceiling installation.</p> | | <p>Wire nail, N2.3b, timber ceiling, central rm, Pontville</p> |

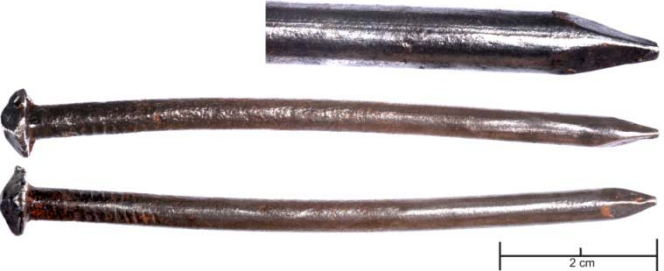
| <p>N2.4</p> | <p>3" Wire steel nail (1); distinct high rose-head with four facets and is roughly rectangular and centred; round shank at head; two minor spurs; eight ribs below head; four sided point. Collected <i>in situ</i> from Oregon Pine batten on detached kitchen roof. Significance: typical of many others and is exact contemporary with kitchen construction. E</p> | <p>Head = 8.0 mm Shank dia. = 4.0 mm Length = 80.0 mm</p> | <p>Wire construction nail, N2.4, Pontville</p> |

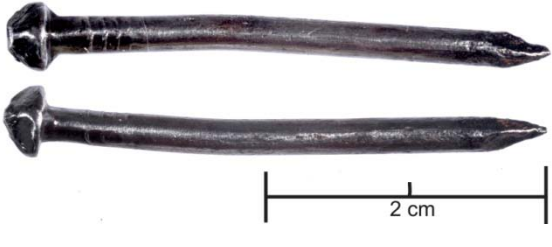
| <p>N2.5a</p> | <p>1½" Wire nail (1), distinct round rose-head with four steep facets; two major spurs only; four sided point. Collected <i>in situ</i> from timber cladding, interior wall of detached kitchen. Significance: is exact contemporary with first timber lining of kitchen. E</p> | <p>Head dia. = 5.0 mm Shank dia. = 2.5 mm Length = 38.5 mm</p> | <p>Wire nail, interior cladding, detached kitchen, Pontville</p> |

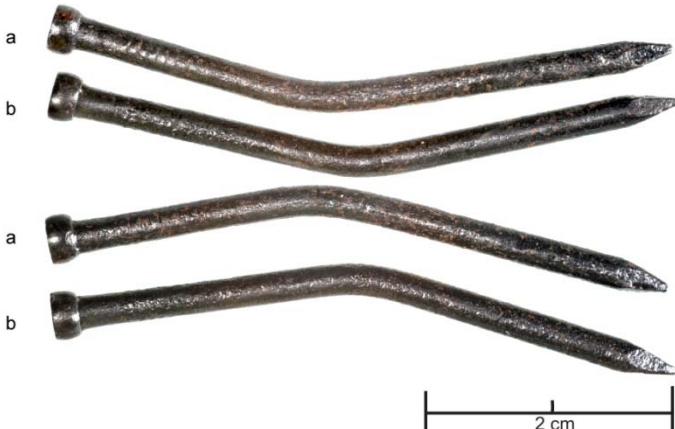
| <p>N2.7</p> | <p>2" Wire bullet-head nails (3); round, un-faceted flat head; four sided point. Collected <i>in situ</i> from exterior Baltic Pine cladding of detached kitchen. Significance: is interpreted to be contemporary with repairs to fix loose cladding.</p> | <p>Head dia. = 4.0 mm Shank dia. = 2.5 mm Length = 50.0 mm</p> | <p>Wire nail, N2.7a & b, ext cladding, Pontville kitchen</p> |

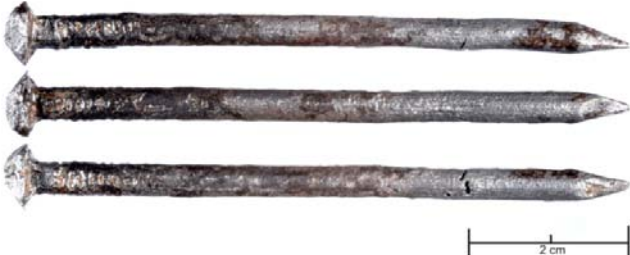
| <p>N2.12</p> | <p>3" Iron wire rose head nail (1). <i>In situ</i> in noggings of detached kitchen. Irregular rectangular robust head w/ four facets. Shank w/ four sets of indistinct grip marks, square shank at head, shaft otherwise round, one set of opposing spurs, point with four facets. Metal failure (greenstick break) on shaft and tip is split along the grain. Iron construction. A</p> | <p>Head = 8.6 mm Shank =4.4 mm Length: 75.0 mm</p> | <p>Construction wire nail, nail N2.12; Pontville</p> |

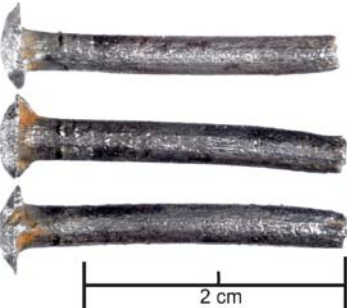
| <p>N2.13</p> | <p>Incomplete iron wire nail (1). Thin, cusped rose head joins square neck with faint grip marks on an otherwise round shaft. Well formed haunch beneath head. Grip marks are <i>raised</i> above shank surface. Missing shank to mid-shaft. Found loose in sub-floor cavity. A</p> | <p>Head = 6.5 Shank =2.8 Length: 24.2 mm</p> | <p>Wire Nail, Nail N2.13; Pontville</p> |

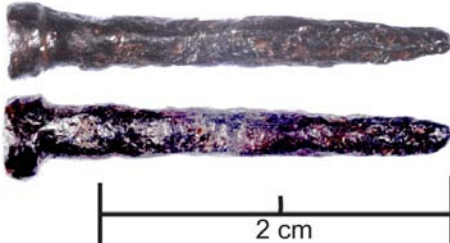
| <p>N2.14</p> | <p>1" wrought iron wire lath nail (1), probably hand forged, badly corroded. Head offset and roughly round, shank tapered full length to point. Taken <i>in situ</i> from underside of pit sawn ceiling joist in central room of house from area clearly stained by plaster application. Significance: is exact contemporary of ceiling installation, probably the timber panelling. E</p> | <p>Head dia. = 5.4 mm Max shank dia. 3.0 mm Length = 25.6 mm</p> | <p>Lathing Nail,N2.14, Pontville</p> |

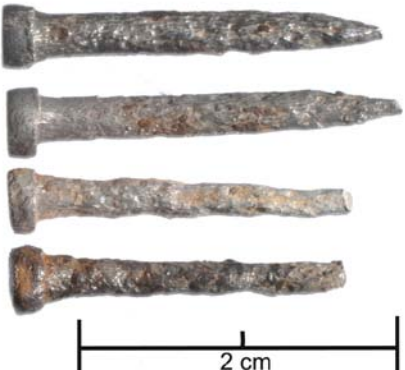
| <p>N2.15</p> | <p>Lathing nails (4). Flat round head w/ slight concavity on top; round shank throughout its length, tapering to sharp point. Shank diameter is slightly enlarged at head. Two sizes recognized, a slighter version tapers from close to the head, the other tapers in 1/4 distance of point. Collected loose from beneath central room floor and one was found <i>in situ</i> in ceiling joist. A</p> | | <p>Lathing tacks, N2.15a-d; Pontville</p> |

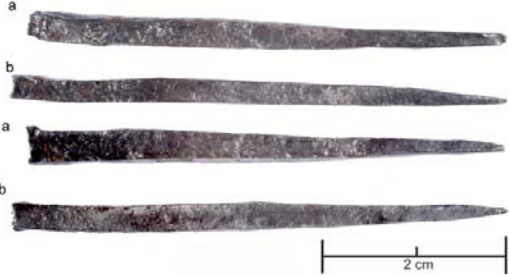
| No. | Description | Measurements | Image |
|---|--|--|--|
| <p>N3.1</p> | <p>2" wrought iron cabinet makers cut nails (2) with taper on four sides of shank to create sharp point and spur head. Lug head on one nail. Definite hand-forged taper, modified cut nail. Rectangular shank at head. Taken <i>in situ</i> from timber spacer strip, front edge of window surround, west wall, central room. Significance: directly associated with assembly of window surround in central and north rooms. E</p> | <p>Shank = 3.1 x 2.6 mm Length = 49.0 mm</p> | <p>Cabinet Makers Brads, N3.1, hand made, Pontville</p> |

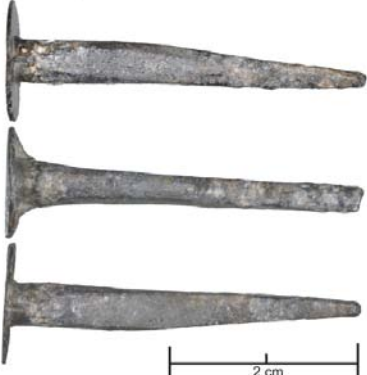
| No. | Description—zinc alloy roofing clouts | Measurements | Image |
|---|--|--|--|
| N4.1 | Loose from top of loft wall, north room; roofing clout, zinc alloy, slate may adhere to shank at junction with head. Do not chemically treat | Head = 12.7 Shank = 3.3 x 4.7 m Length = 37.5 mm | <p>Zinc alloy cut clout, N4.1, Pontville</p> |

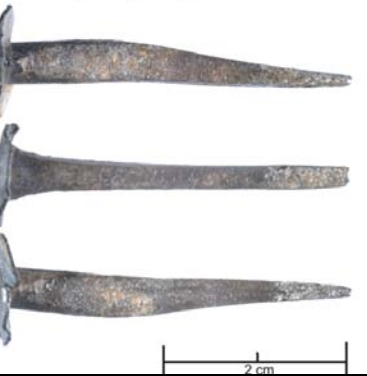
| No. | Description—zinc alloy roofing clouts | Measurements | Image |
|---|--|--|--|
| N4.2 | Roofing Clout, found loose either in loft or subfloor area; unused and shaft is in excellent condition | Head = 12.3 x 10.7 mm Shank = 3.0 x 4.5 m Length = 37.7 mm | <p>Zinc alloy clout, N4.2, Pontville</p> |

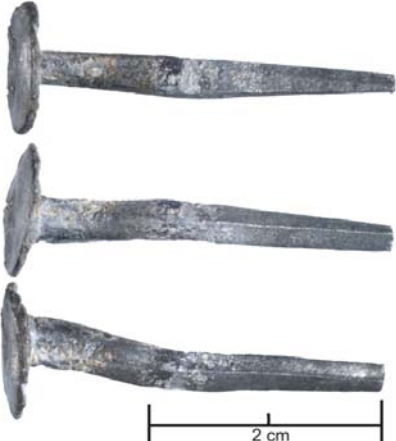
| <p>N4.6</p> | <p>Solid cut Zinc alloy slate roofing clout (1), asymmetric taper from mid-shank to pointed tip. Extrusion spurs on underside of head are distorted by slate. This nail is a Type 2 zinc nail and was taken loose from loft cavity area, central room. Significance: this type of nail was used to fix either shingles or slates to the roof at Pontville.</p> | <p>Max. shank = 4.0 x 3.0 mm Head dia. =11.4 mm Length = 33.0 mm</p> | <p>Zinc alloy clout, N4.6: Pontville</p> |

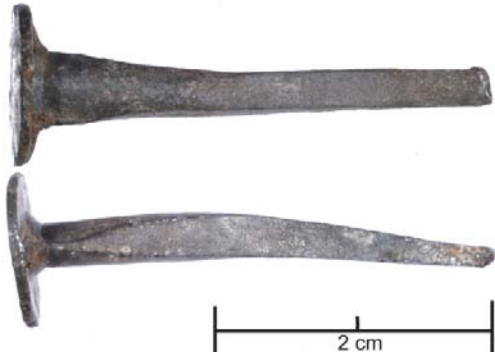
| <p>N4.9</p> | <p>Solid Zinc alloy slate roofing clout (1), asymmetric taper from mid-shank to pointed tip, round flat head with two opposing major spurs. One-piece construction. Taken loose from sub-floor area, central room. Excellent condition, probably unused. Shank taper created by shearers cutting one side from mid-point to point, head then shaped by press which results in compressed rounded edges of neck and distinctive opposing major spurs on head.</p> | <p>Max. shank = 4.8 x 3.4 mm Head dia. =12.3 mm Length = 34.5 mm</p> | <p>Zinc alloy roofing clout, Type 2, Pontville</p> |

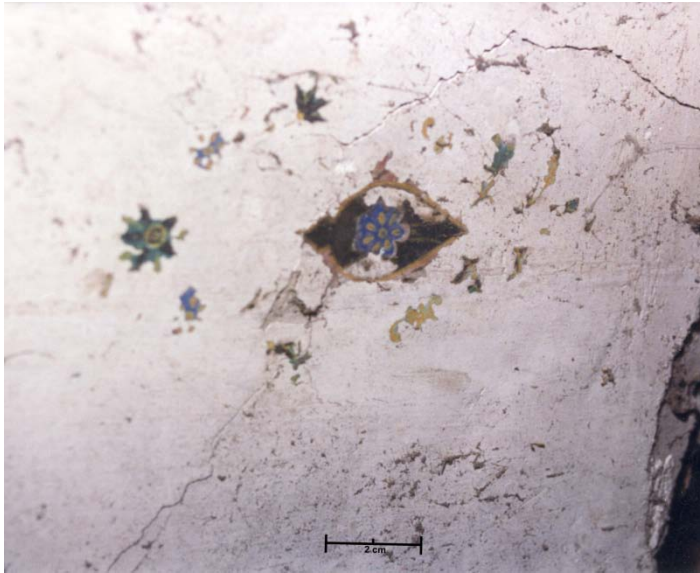
This photograph of Culla Hill wall paper fragments adhering to plaster wall in side loft was assessed by Murphy.

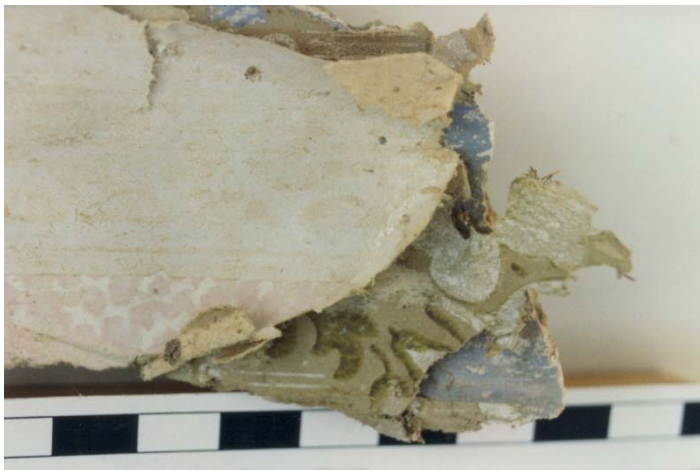
Sample 22 from Pontville assessed by Murphy containing a pattern featuring a floral motif with series of white lines and geometric figures (S22a) beneath paper with pink floral buds lining contrasting bud pattern in linear panels (S22b), overlying blue lime wash. From sub-floor context, south room.

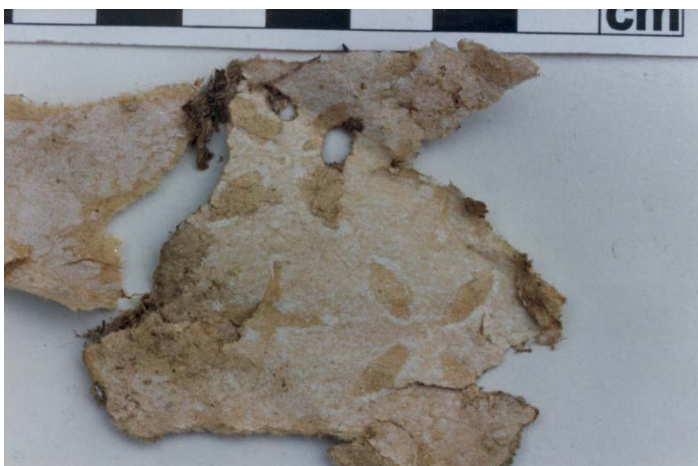
Sample 25 from Pontville assessed by Murphy, from subfloor context.

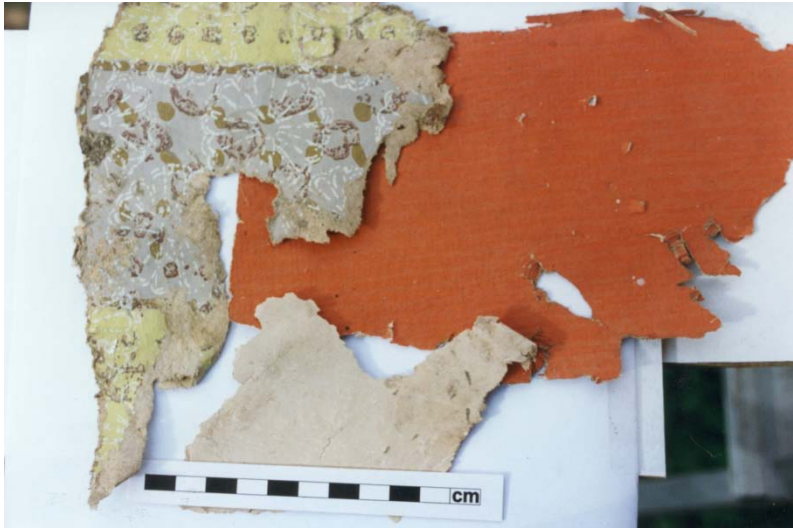
Samples 24 from Pontville assessed by Murphy. Clockwise, top left to right, a) found adhering to wall, b) orange paper located on east verandah core wall, c), from sub-floor cavity, north room. Latter paper was obtained from ceiling plaster found loose in sub-floor cavity, either central or south room.
